Fixing a Church in 7 days

Trinity Pentecostal Church

Brentwood, England

This is a church in a barn

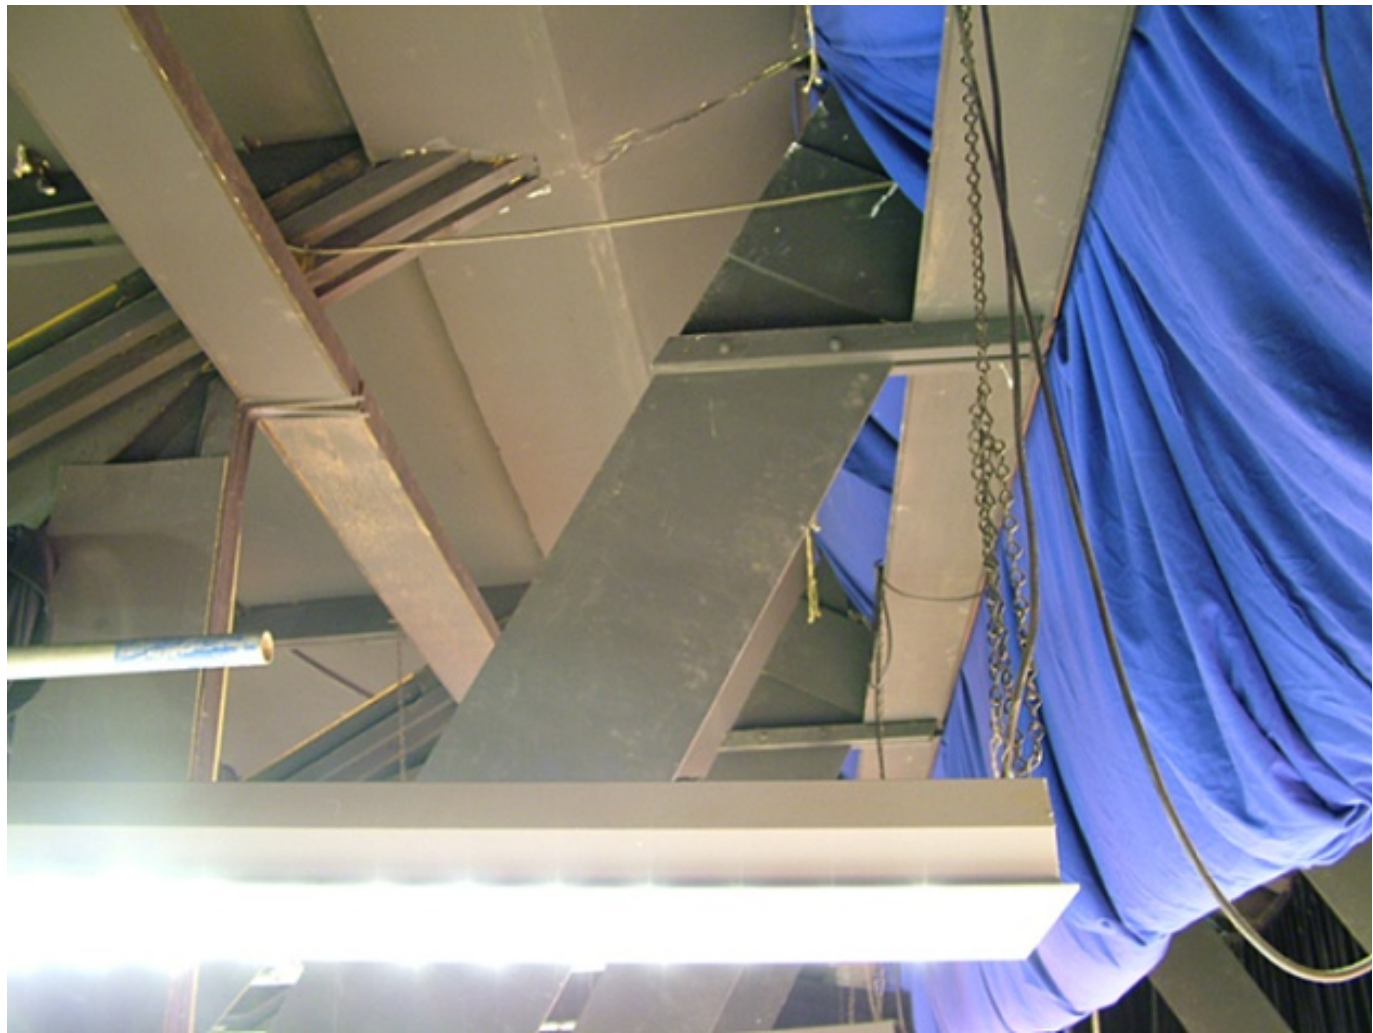
This church wanted a balance between a performance space and a broadcast studio. They tried acoustical curtain on the ceiling. Acoustical curtains do work but I have not been able to find a use for them in a church setting.

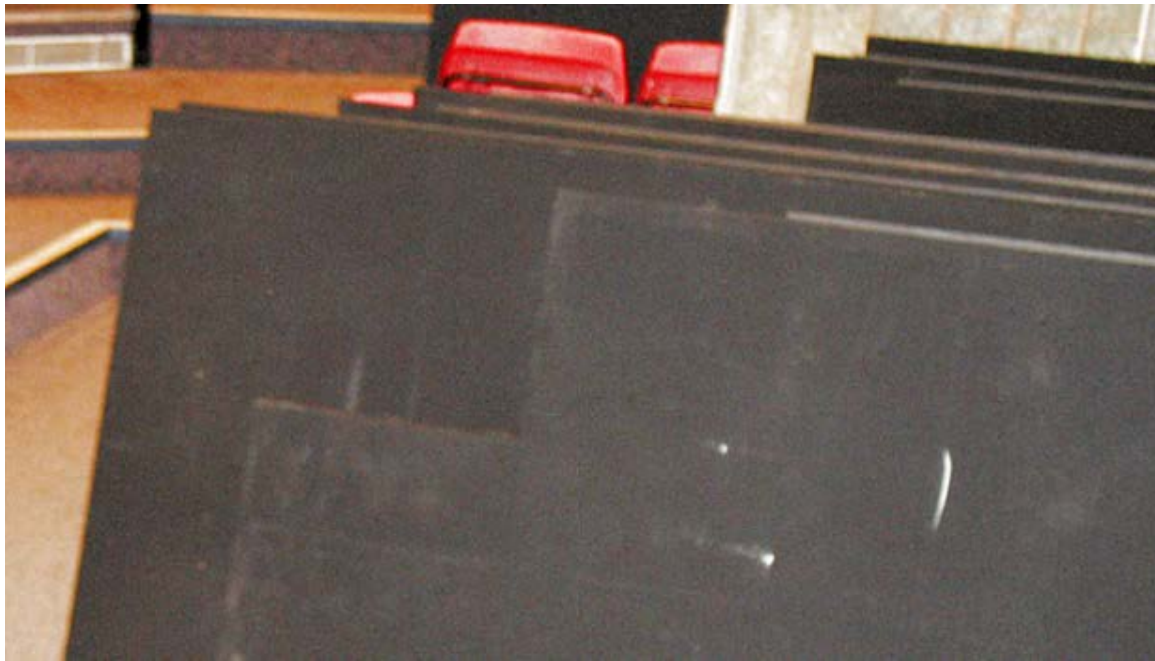
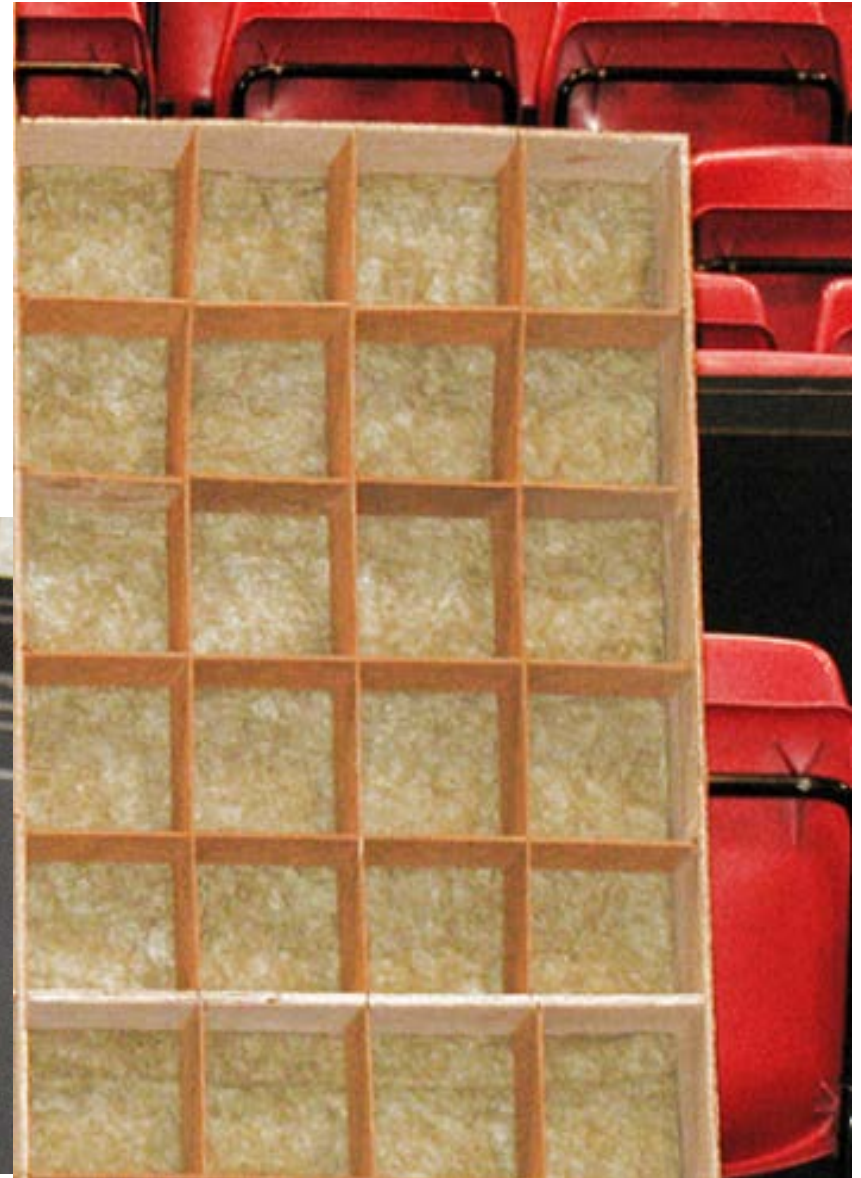
There were over 30 custom made acoustical panels – aprox. 3 x 5ft.

The fronts were 2 inch rock wool.

The backs were 4 inch coffers. These were designed and built to meet the standards used in the BBC TV studio's.

The panels were well designed and they performed as specified but again, their use in a church would be limited.

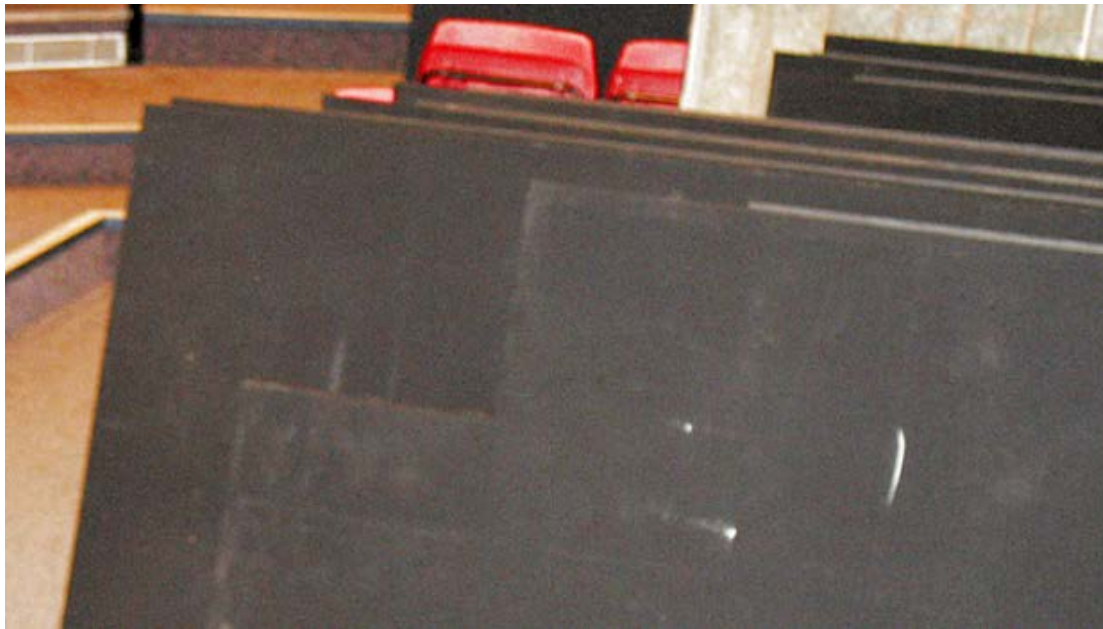
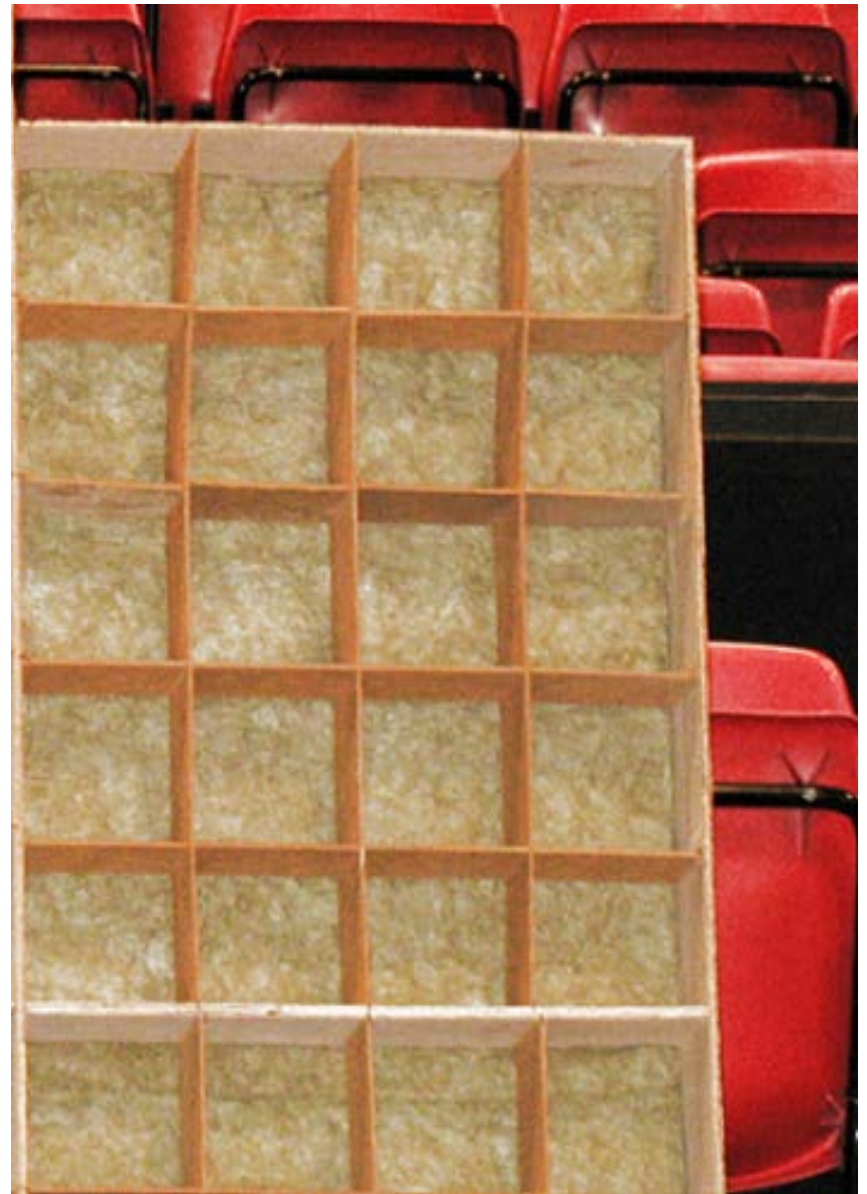
- ◆ These panels were in conflict with the church requirement. While they helped in some areas of room acoustics, they were a problem in other areas. These 8 inch thick panels were not aggressive enough in the frequencies that were problematic in this church.

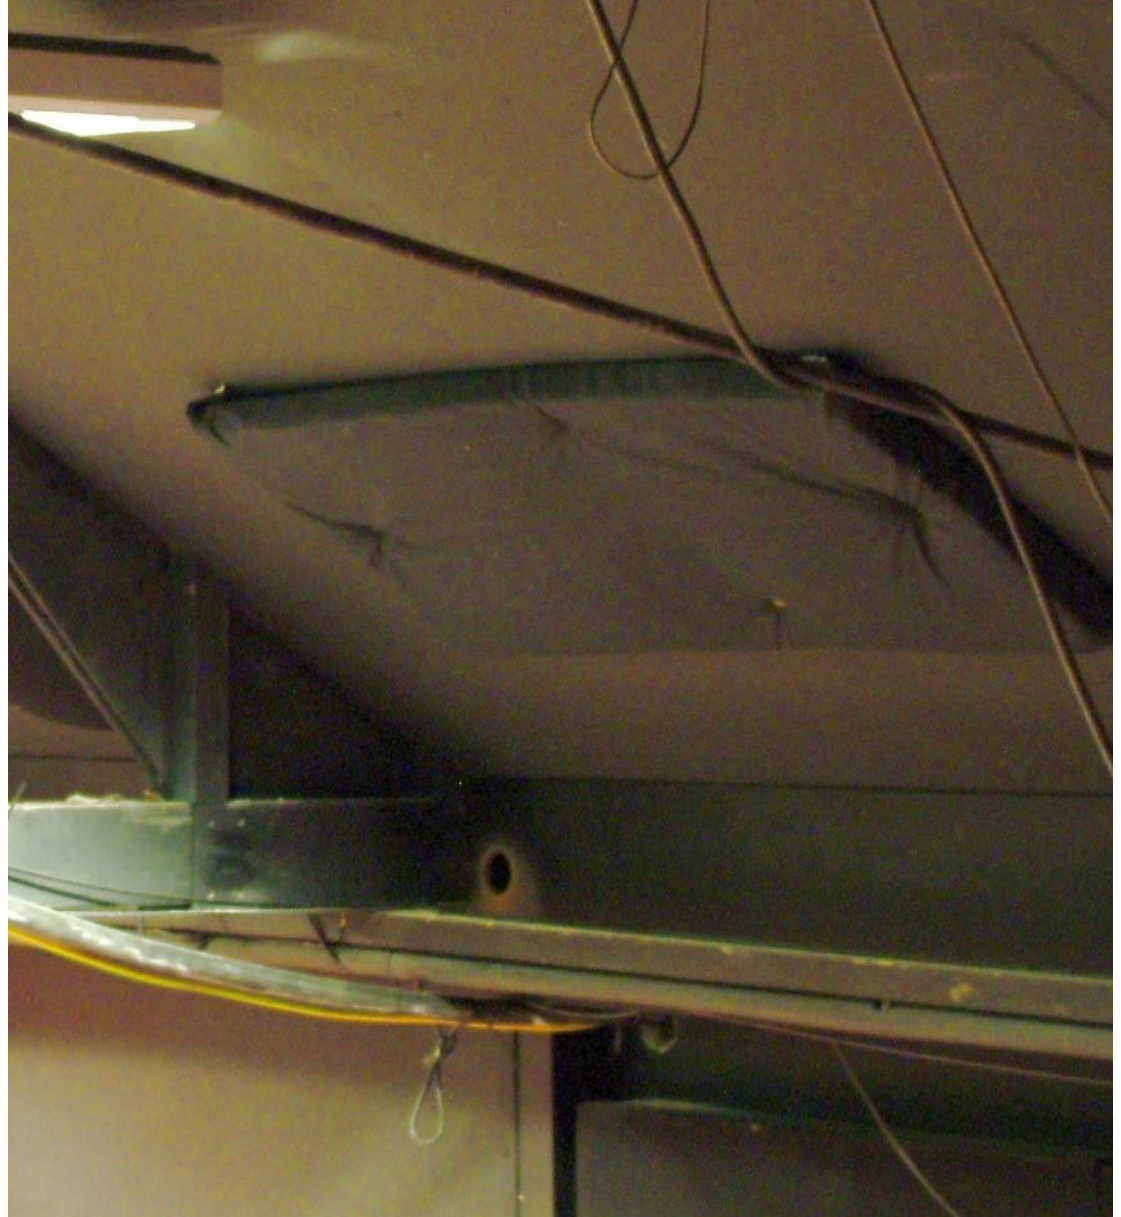
- ◆ The ceiling also had a number of Rock wool Panels. All of these were removed.

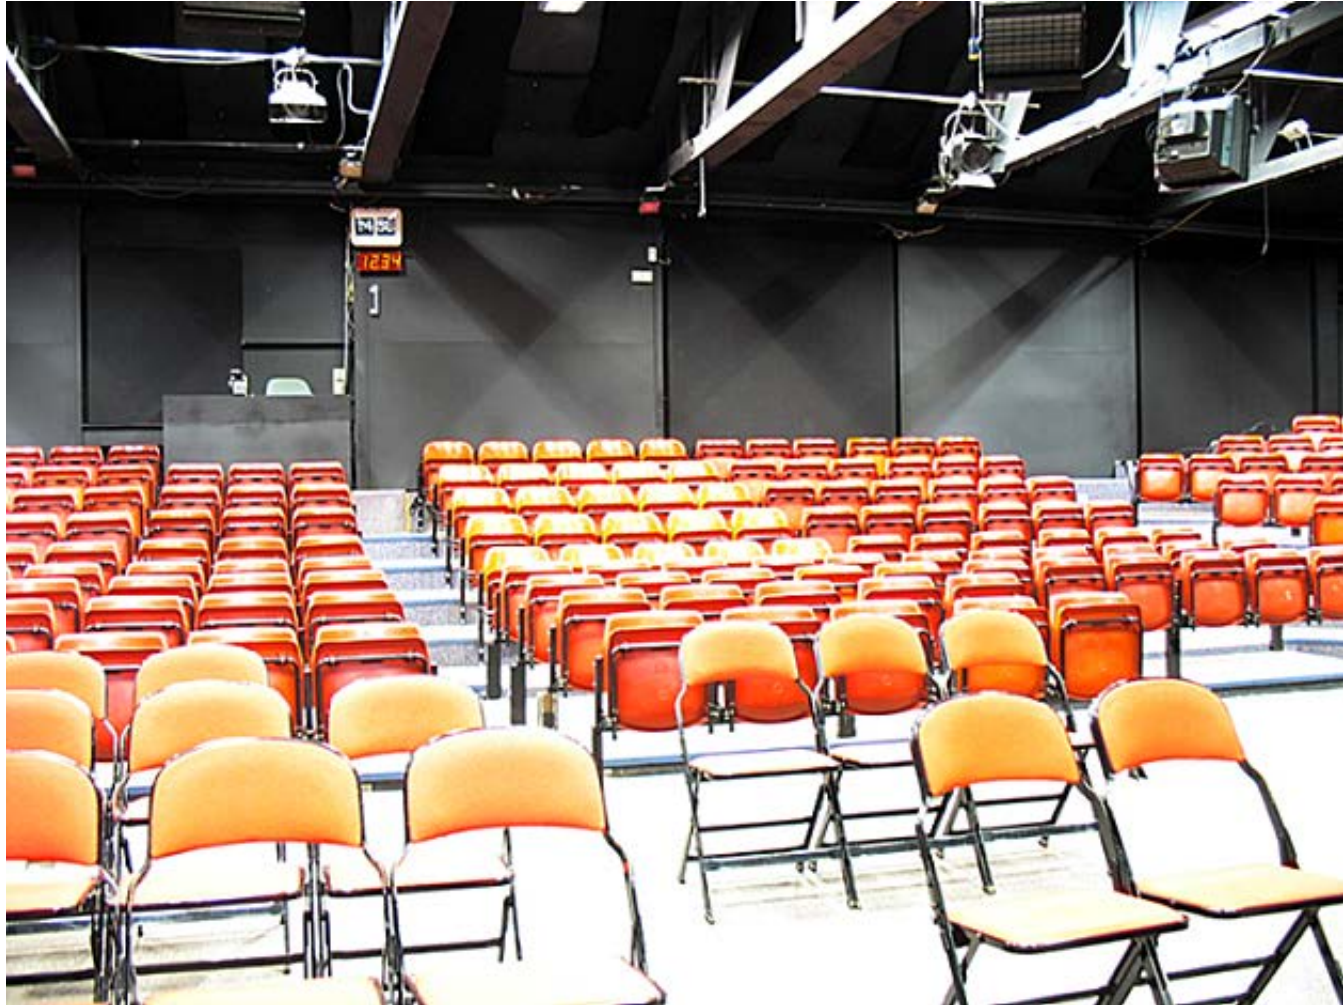
This place was panelled with wall to wall absorber panels. A short time earlier, the church members tried covering up some of the panels with plywood to try to brighten up the room.

Instead, the church found itself exchanging one problem for another.

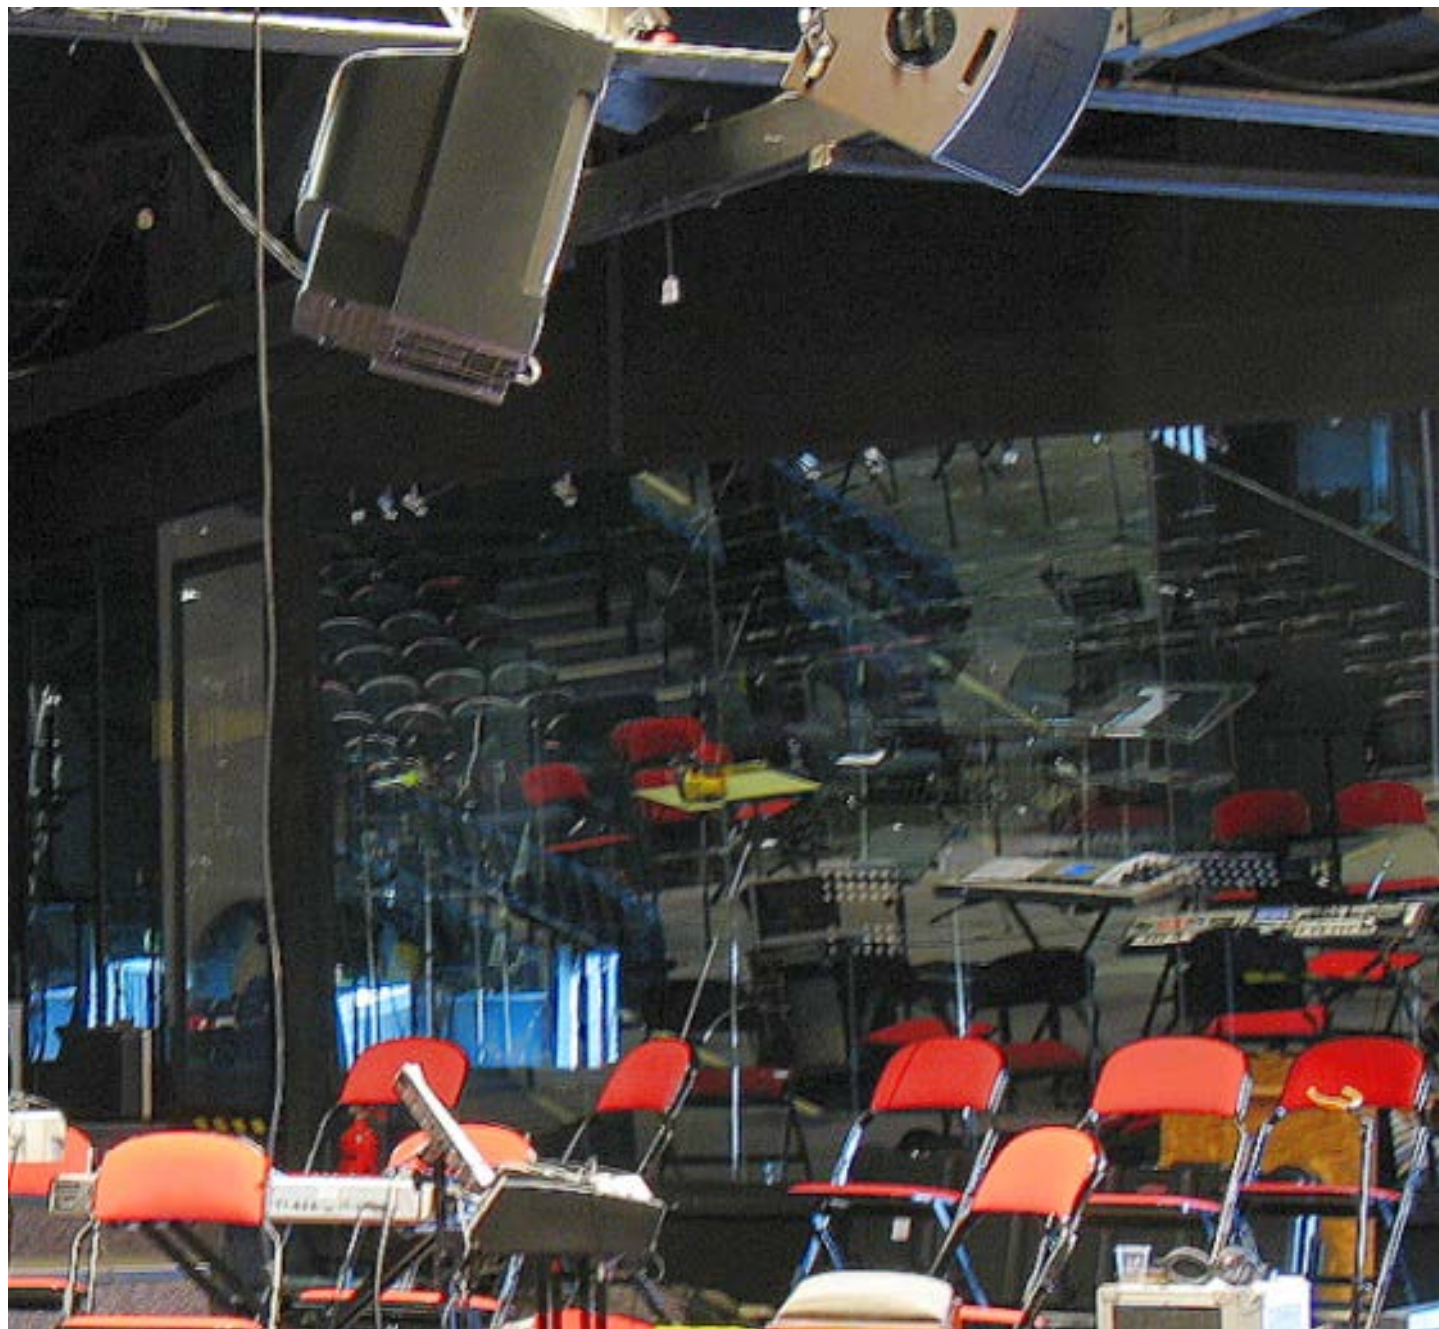
The problems were so out of control that the Drummer was in a glass booth inside of a larger glass booth. The first booth was for the brass instruments.

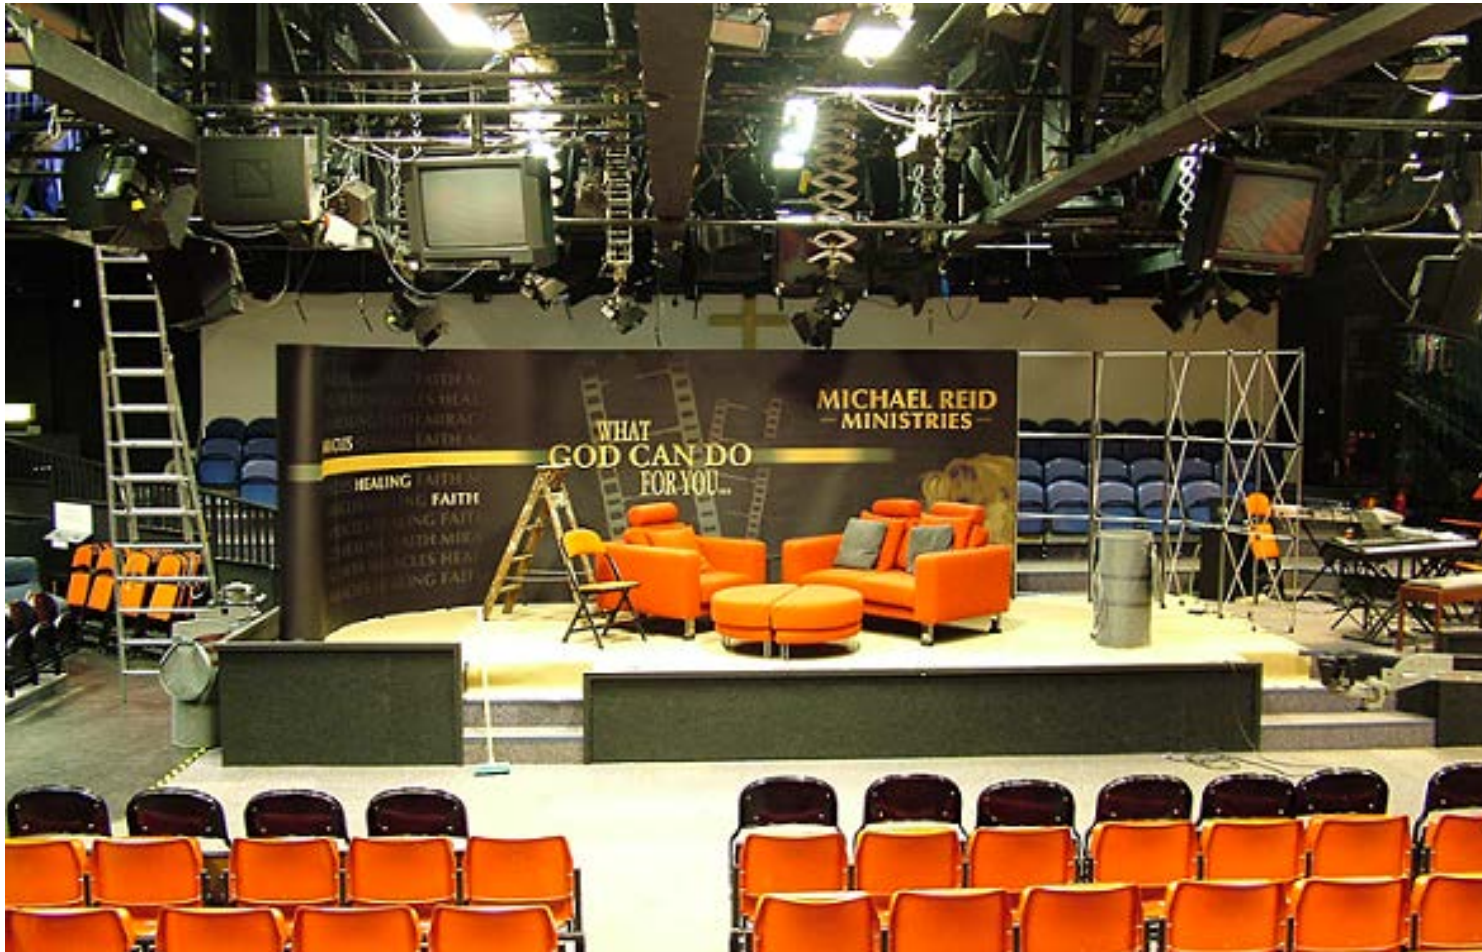
This is the set for the daily talk show. It is part of the worship stage. Even during the interviews the people in the set sounded like they were in tin cans and the audience could not hear - even when only a handful of people were present. Hearing anything was difficult beyond 12 to 15 ft with or without the sound system on.

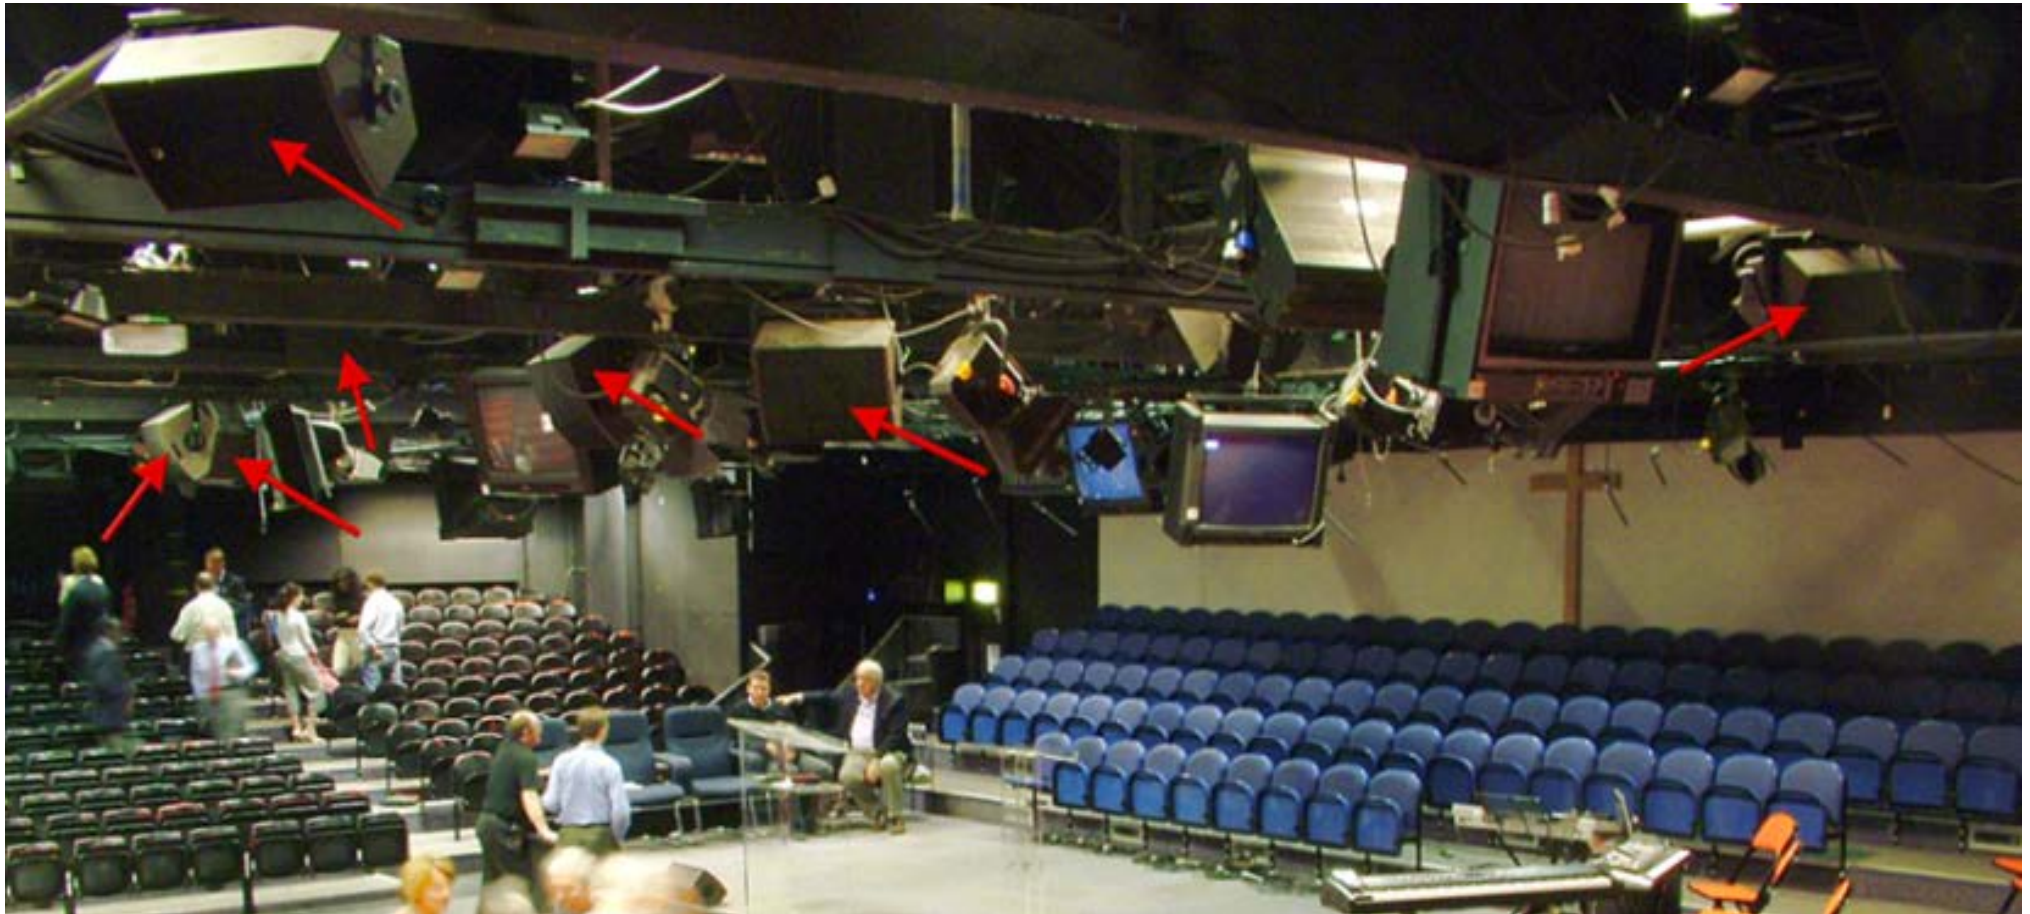
Acoustics were not the only problem. In the photo below is 7 of the 16 plus speakers hung in the ceiling. Just about all of the equipment was good to high end quality and they had enough equipment to do a church seating 2000 people. All of it was reused later after the sound system was re-designed.

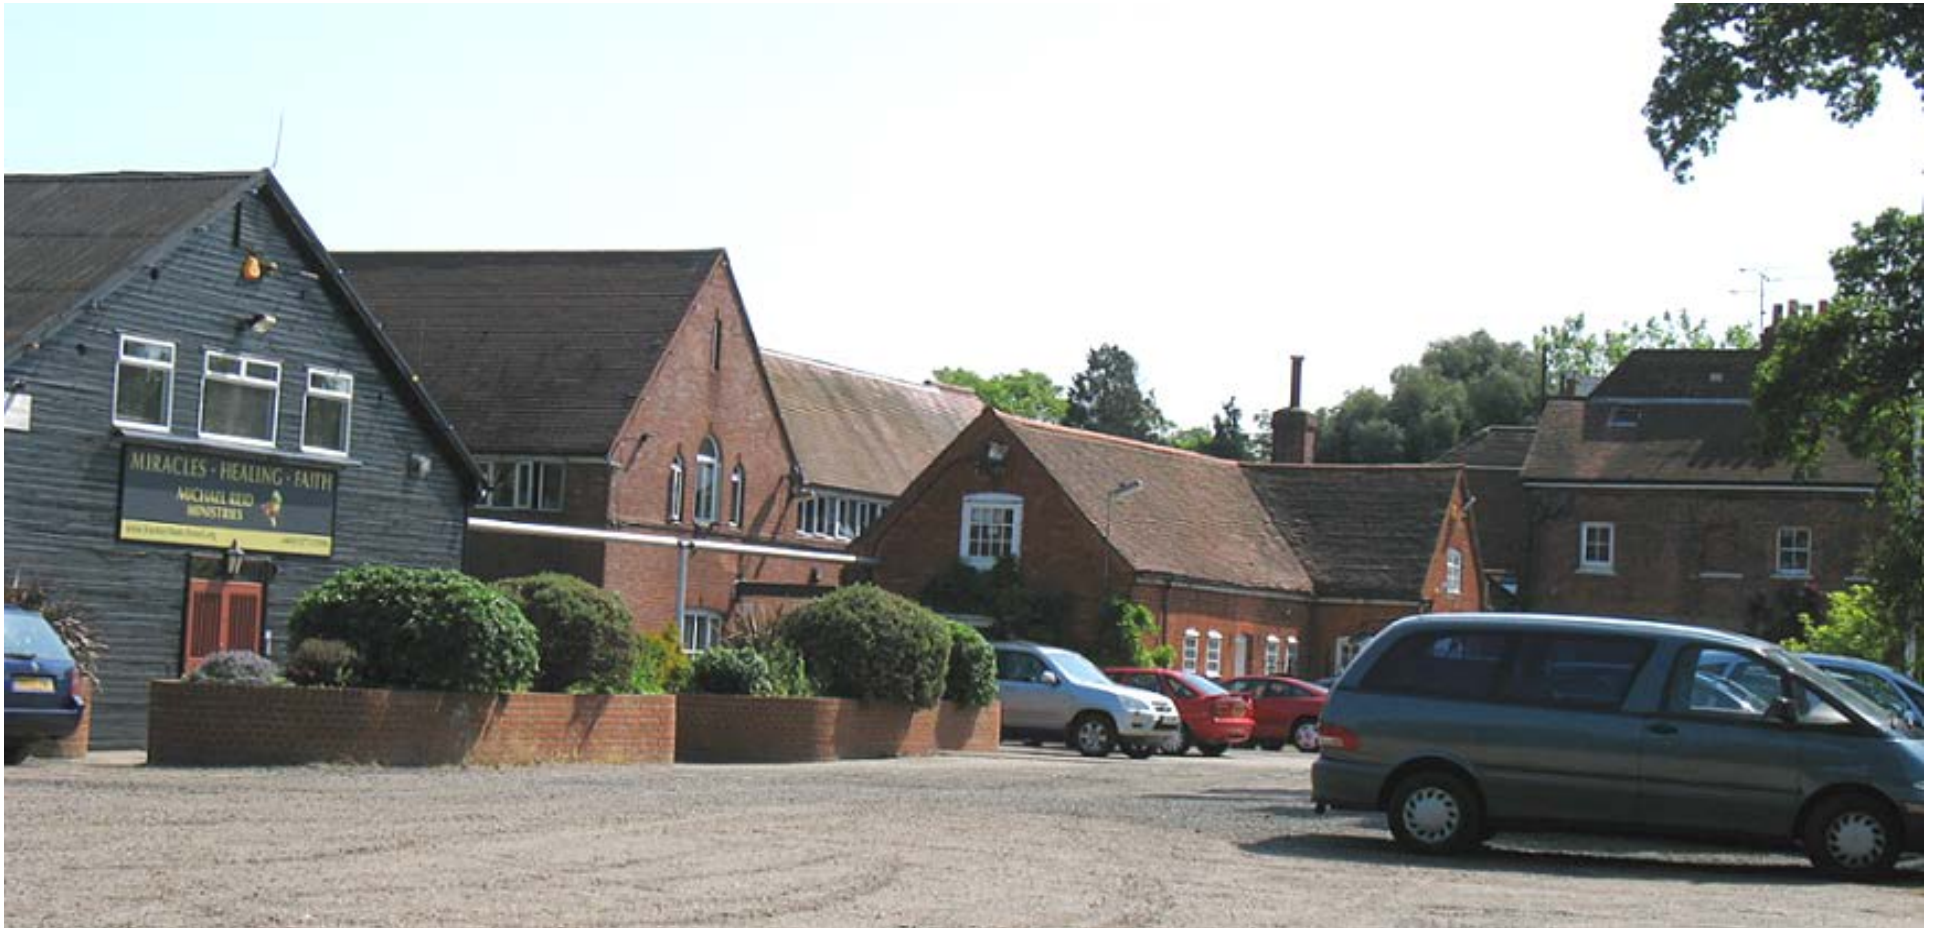
Day 1 part 10

- ◆ After I arrived, I learned that I was not the first Acoustical and Audio expert/contractor they hired to control their sound. I was the 10th.

- ◆ When you see all of the attempts other experts tried at the church, they followed textbook fixes correctly. If you read any books on acoustics and sound system designing, you would have seen many of the elements that were from the books and from popular teachings from Colleges, Universities and from organizations such as AES(Audio Engineering Society), AAA (American Acoustical Association) and CAA (Canadian Acoustical Association.)

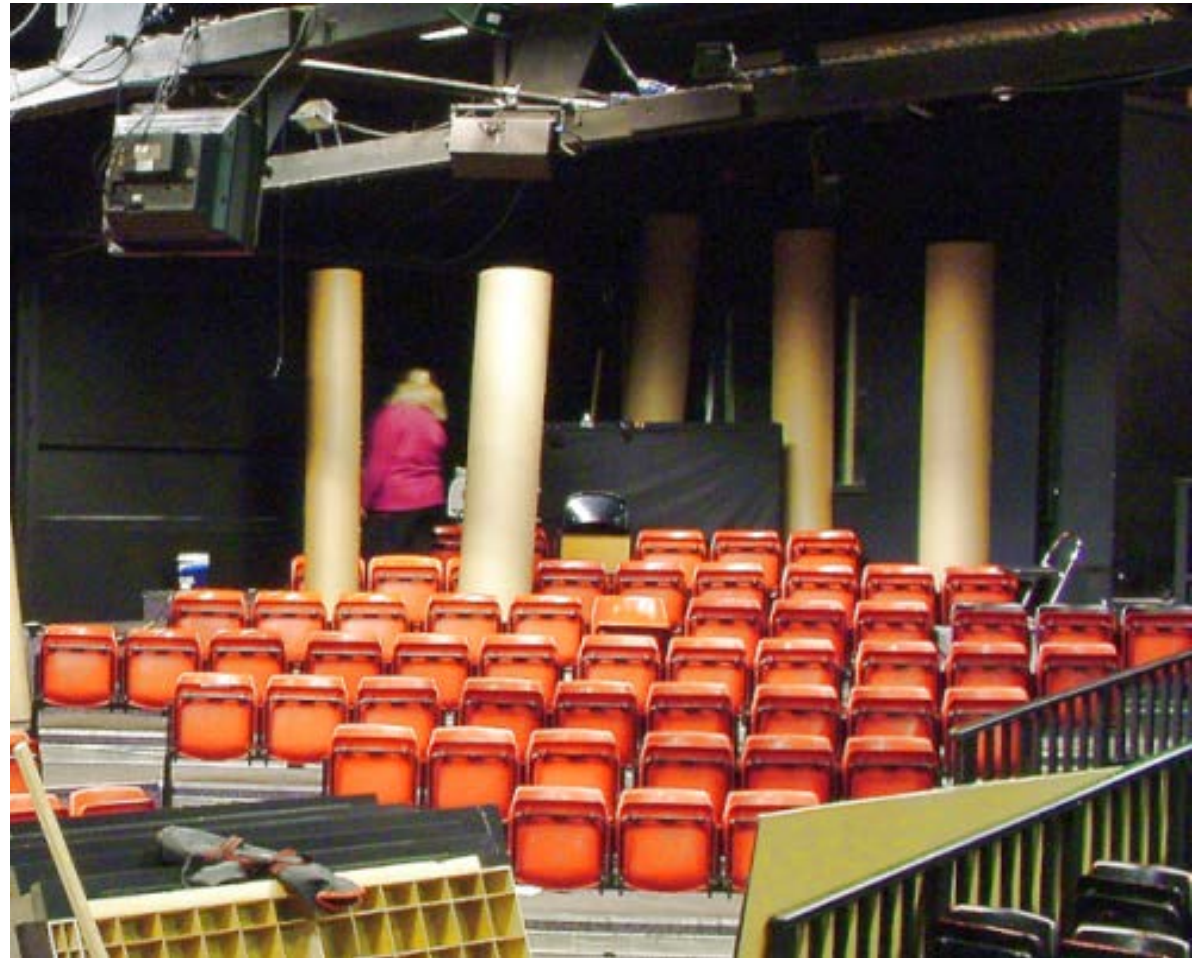
Before anything was started, I asked to have a few tubes just placed against the wall in a trouble spot. Right away the sound effect was removed and it left the area sounding better. After a few more tests, the church members started a work bee that transformed the church in the next 3 days.

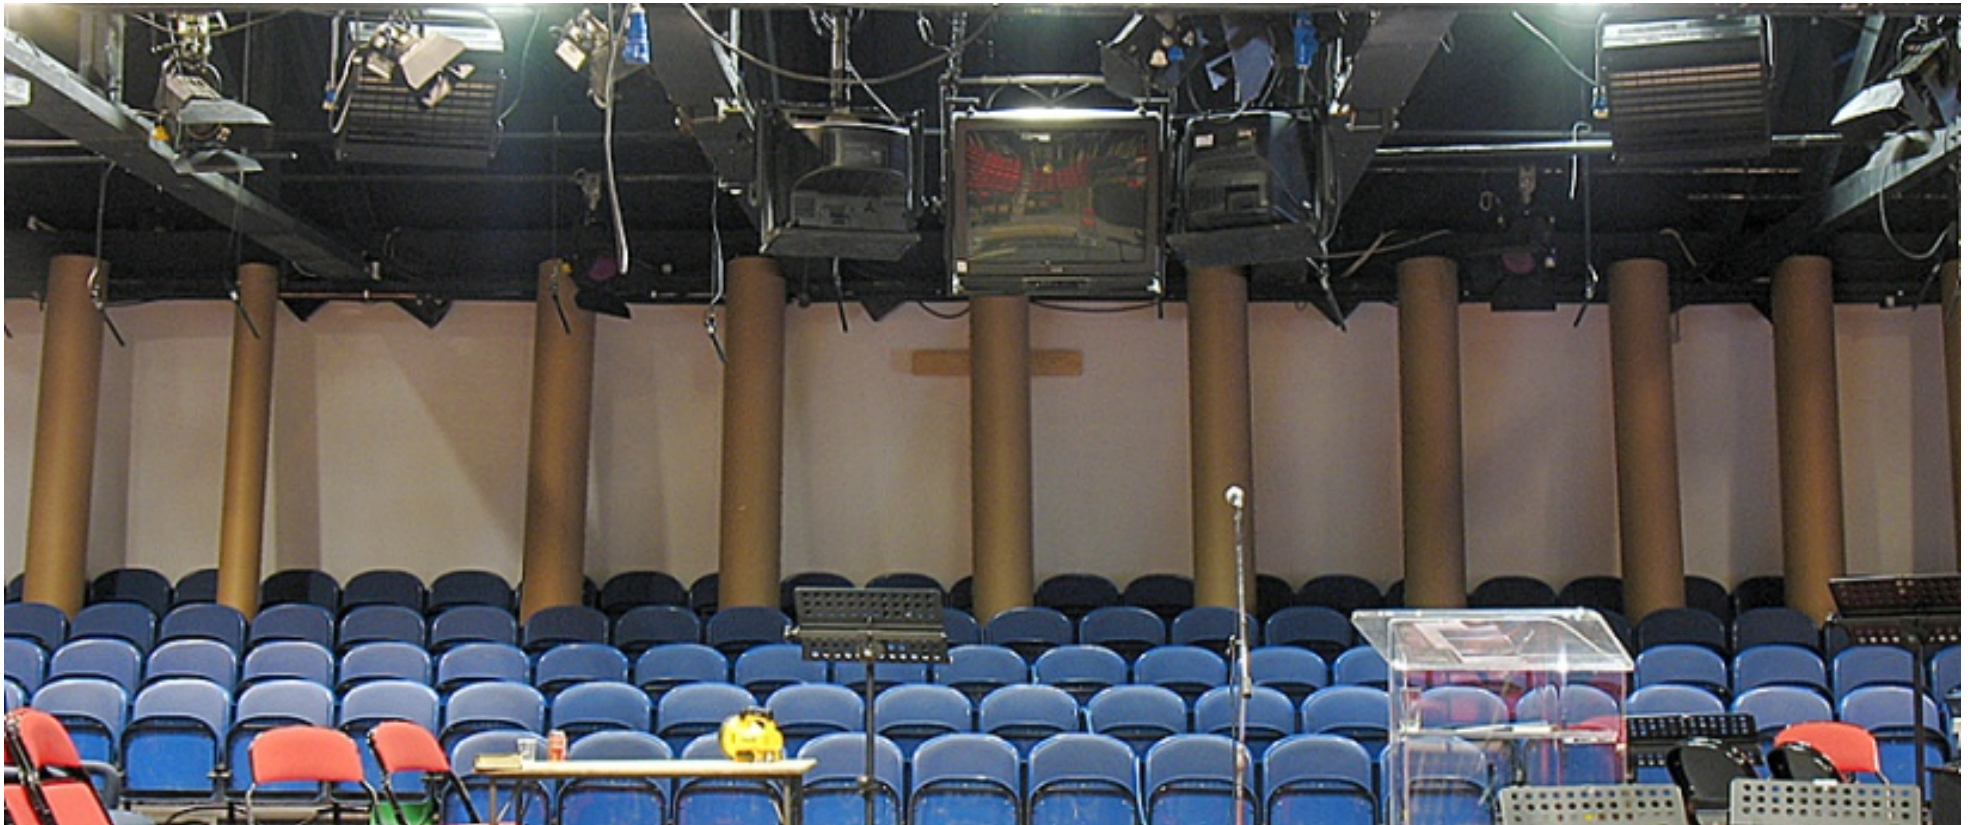
Day 5

- ◆ By the end of day 5 most of the sound system was re-installed and the tubes were laid out ready to be installed.

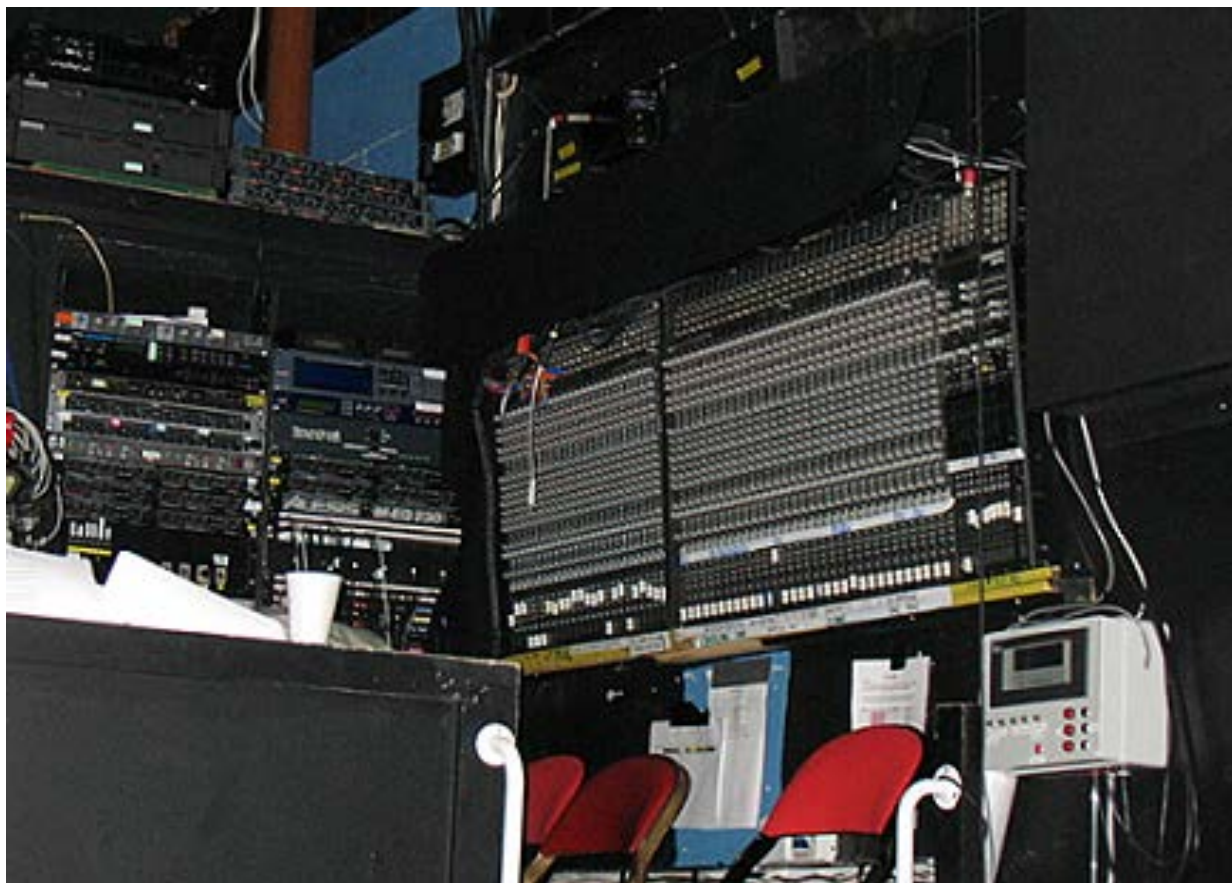
- ◆ Church sound systems often take on a life of their own when trying to correct an acoustical problem with electronics.
- ◆ Acoustical problems drive churches mad.
- ◆ In this case, two mixers were mounted on a wall. They were added to control everything local experts could think of in hope of getting around the acoustical problems.
- ◆ This approach does not work and it never will.

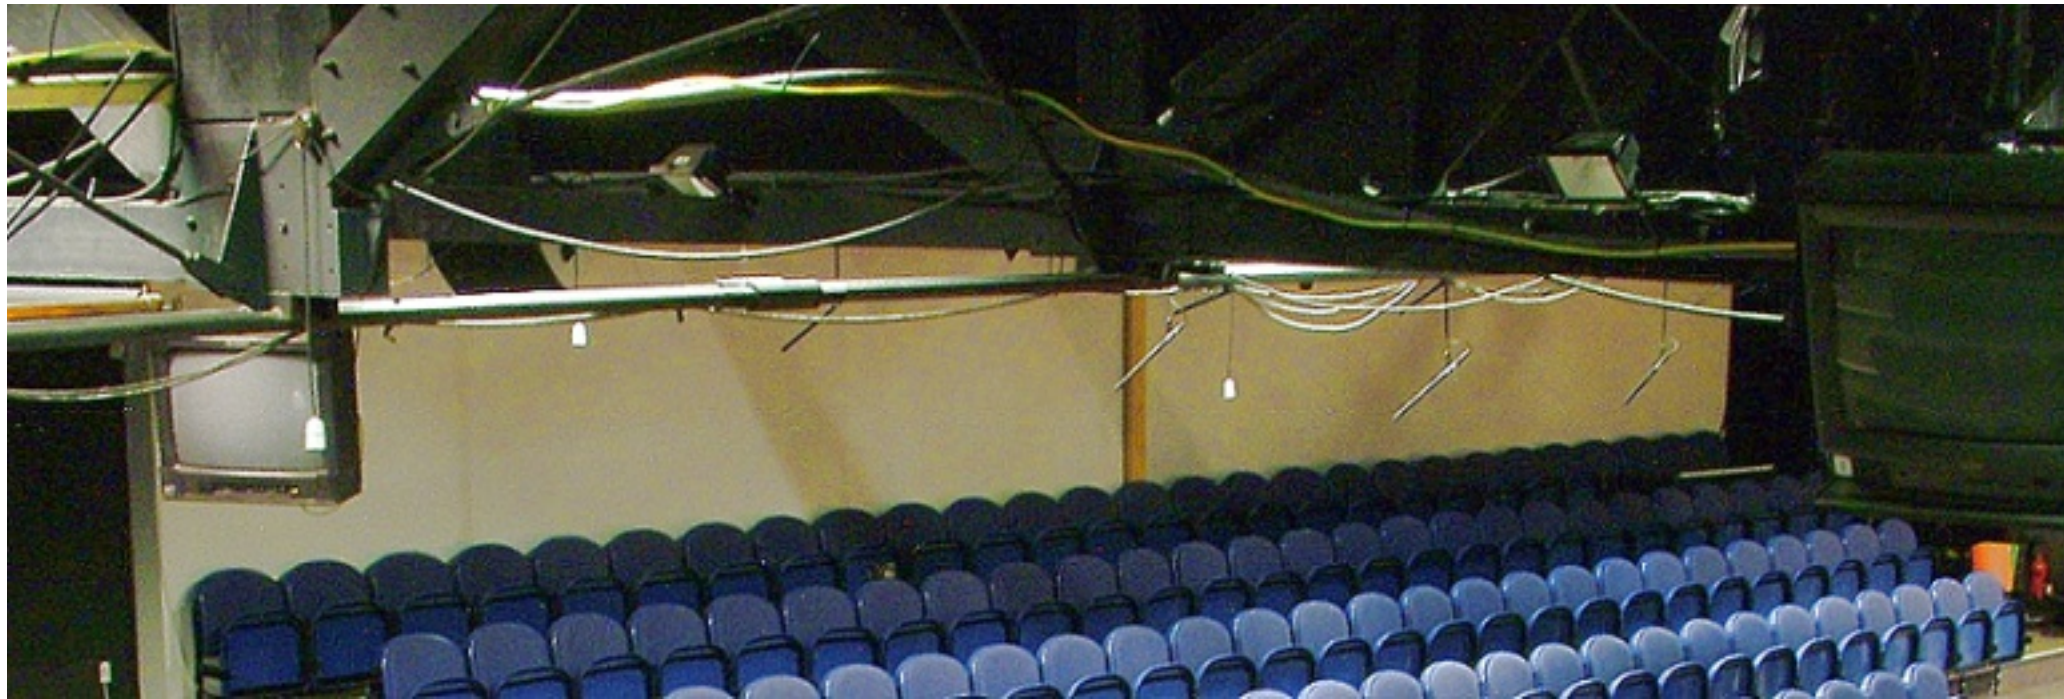
- ◆ This choir loft has over 12 hanging mics. This is excessive, but I do understand why this church installed them. This is how churches often try to over compensate with electronics when the room gets in the way.
- ◆ Many soundmen often wish that just once the room would take off and leave the sound system alone. :-)

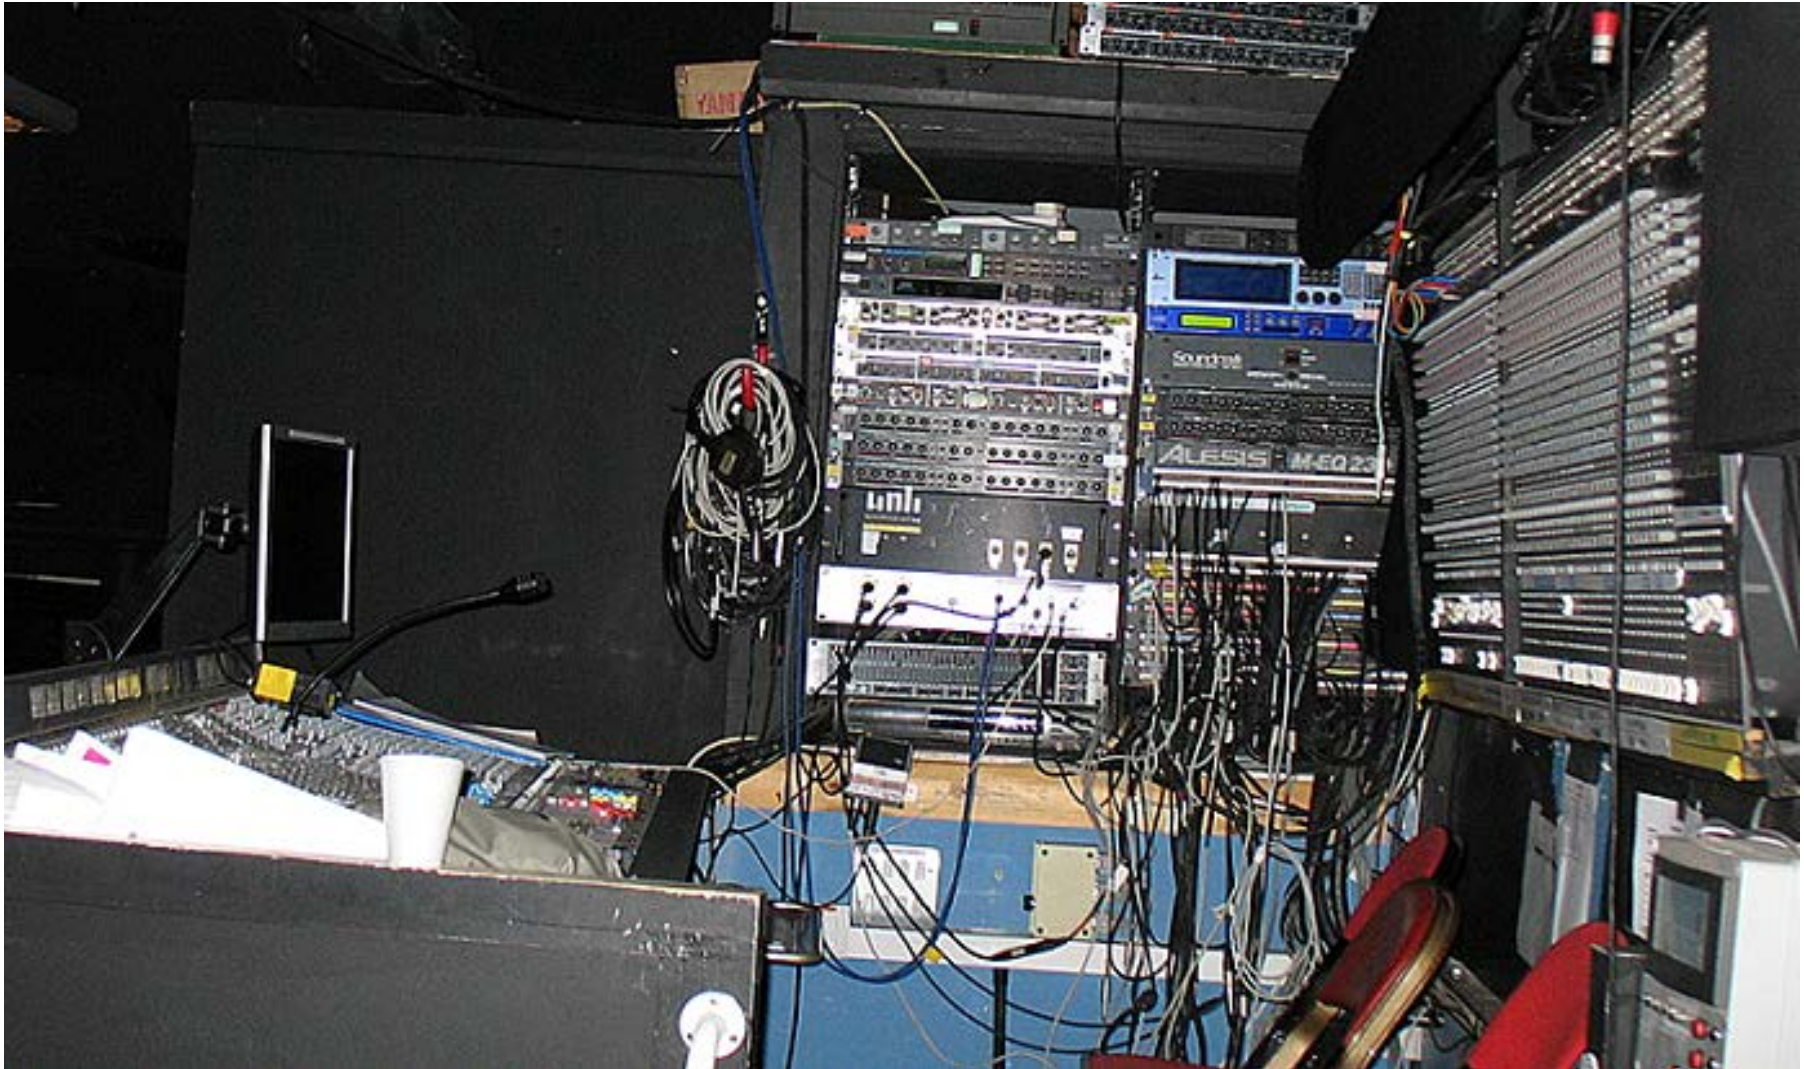
- ◆ This setup is confusing, even for a veteran like myself, but I do understand why a church allows things like this. With a newly re-configured sound system, some of this mess can go away.
