Fixing a Church in 7 days

Trinity Pentecostal Church

Brentwood, England

This is a church in a barn

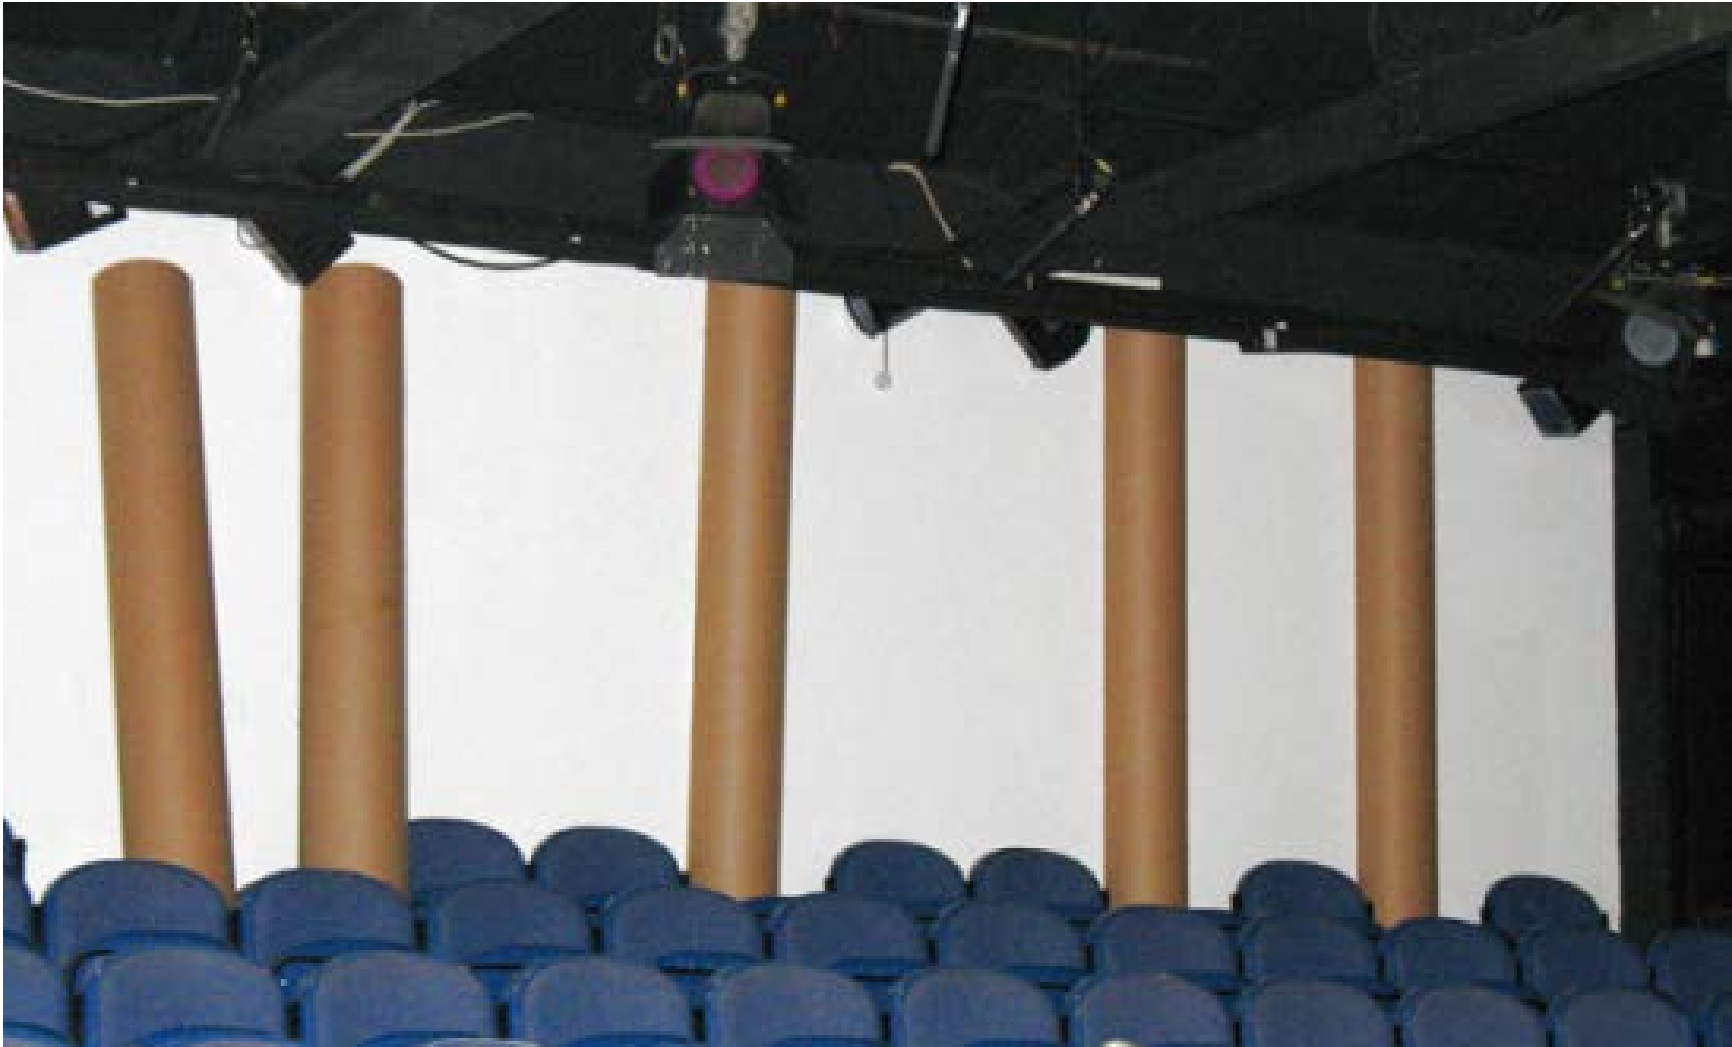
Day 6

- ◆ By the end of day 6, 90% of the tubes were installed in phase one of this project.

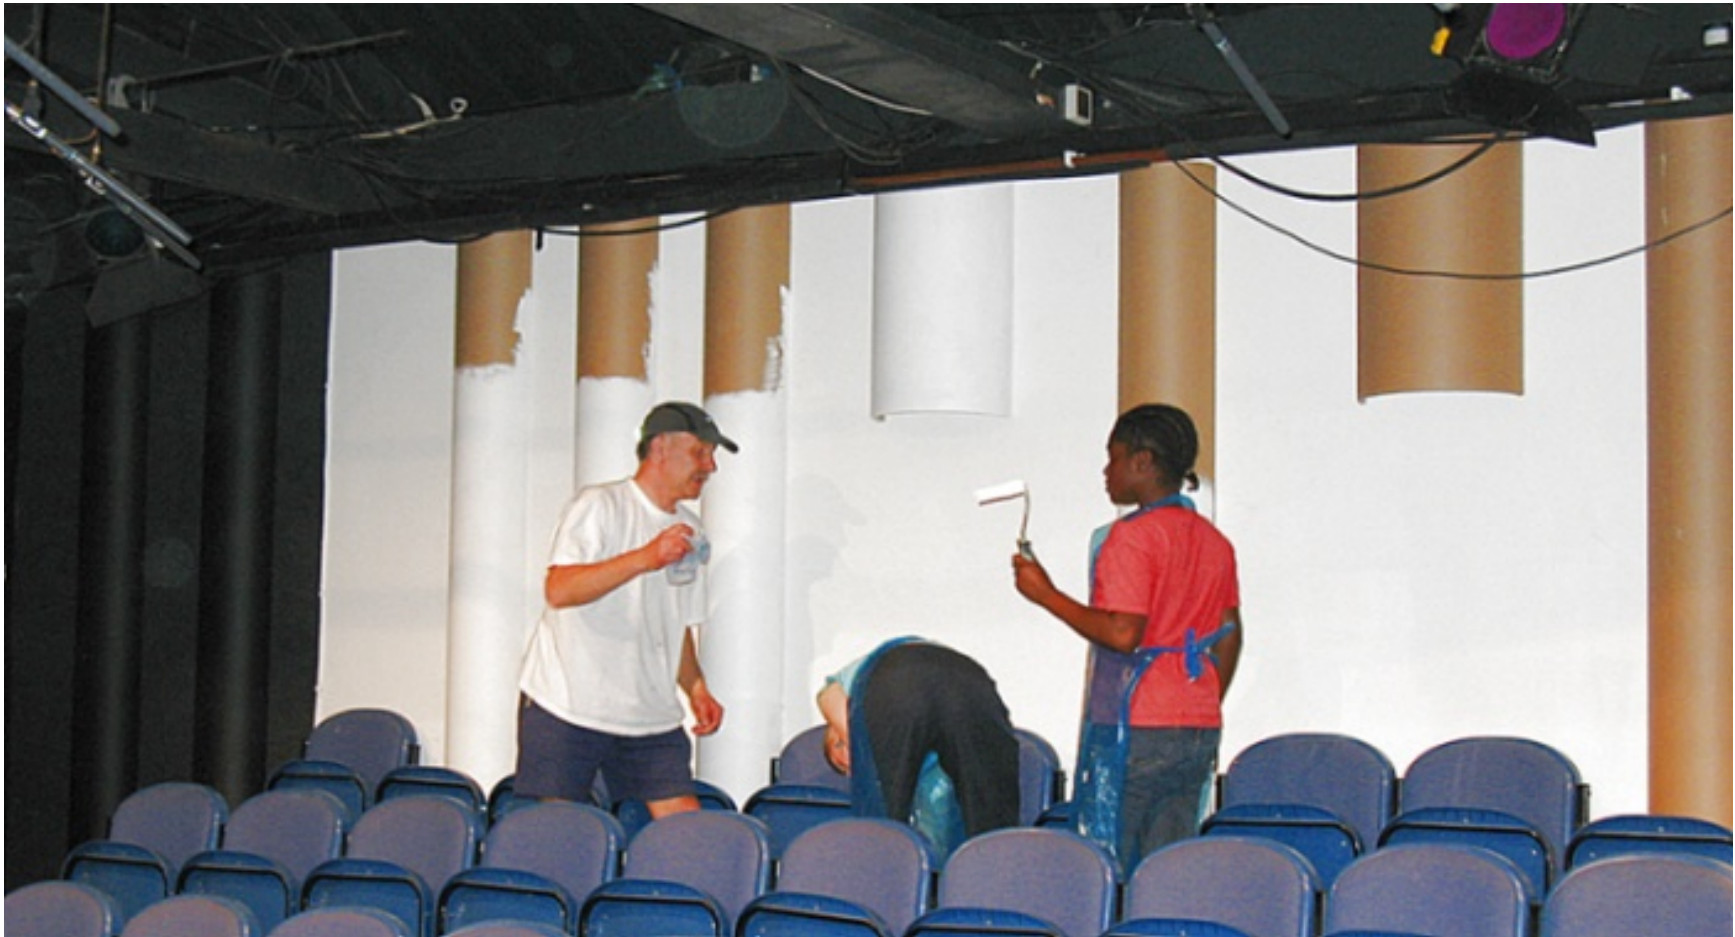
Day 7

- ◆ The church ask the youth people, members and students to help out. Painting was still going on just hours before the first evening worship service.

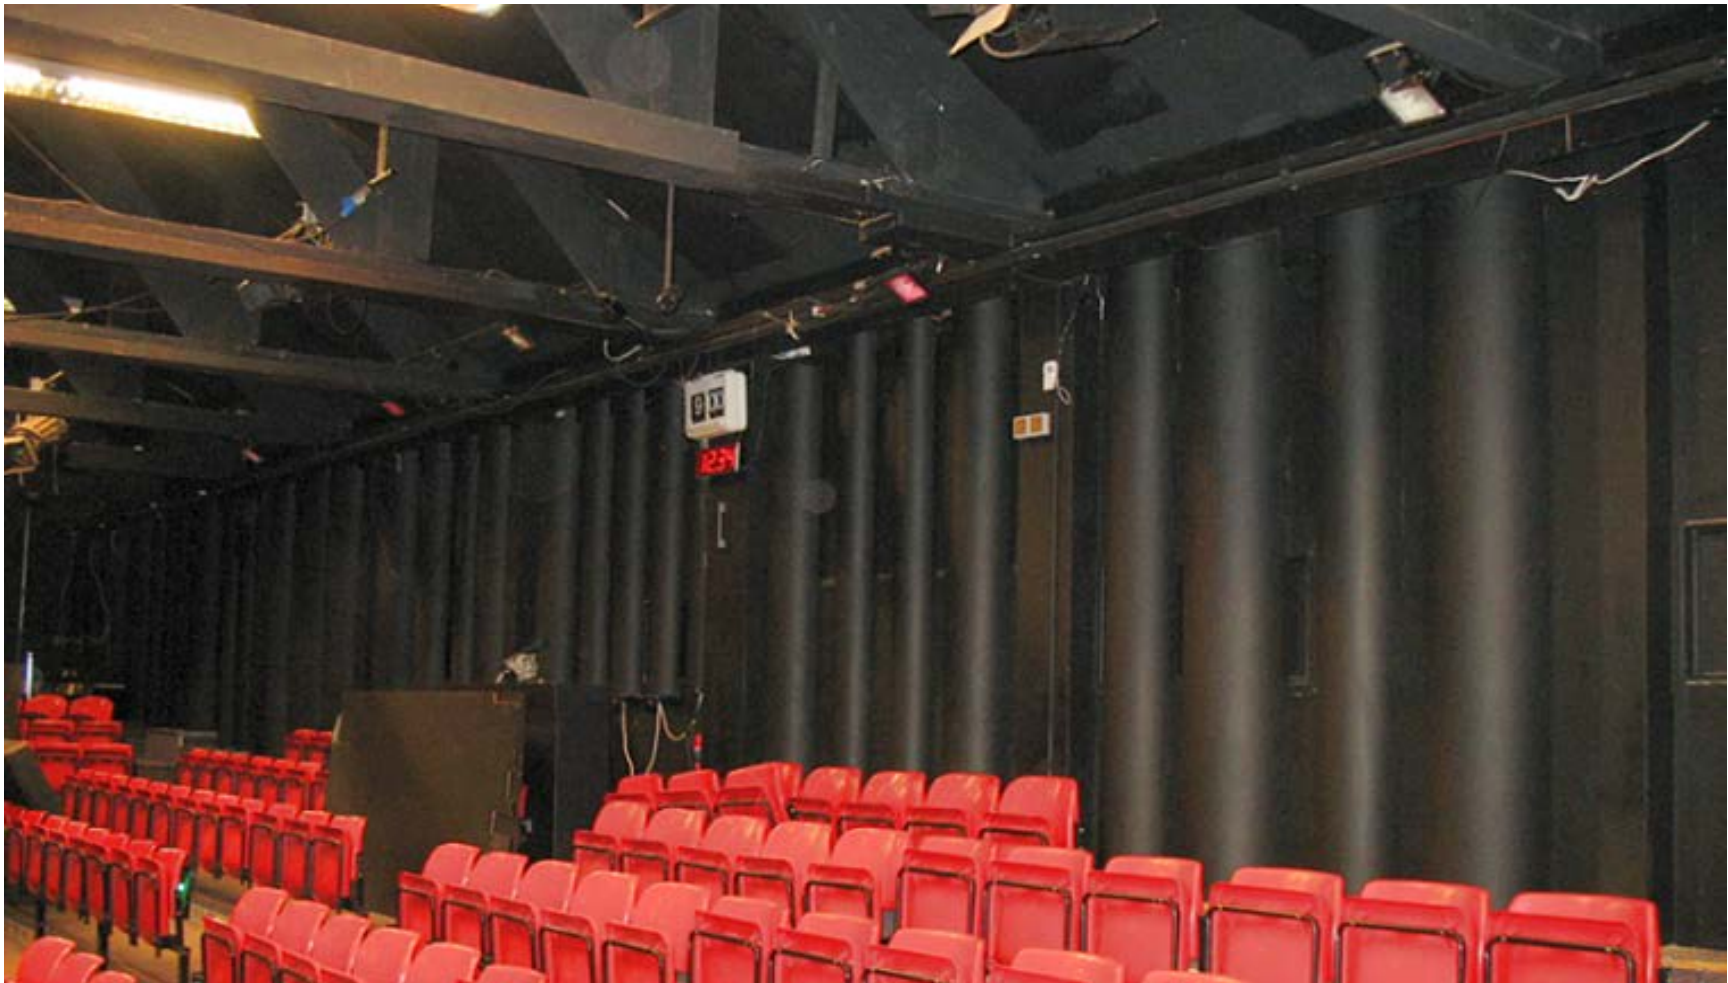
- ◆ The finished tubes are later to be hidden behind curtains.
 - ◆ Curtains have no impact on the frequencies the diffusers are used to manage.
- ◆ The tubes are different sizes. Although they look to be in a random pattern, they do follow a specific prime number sequence that is unique to this room. This pattern may never be used again.

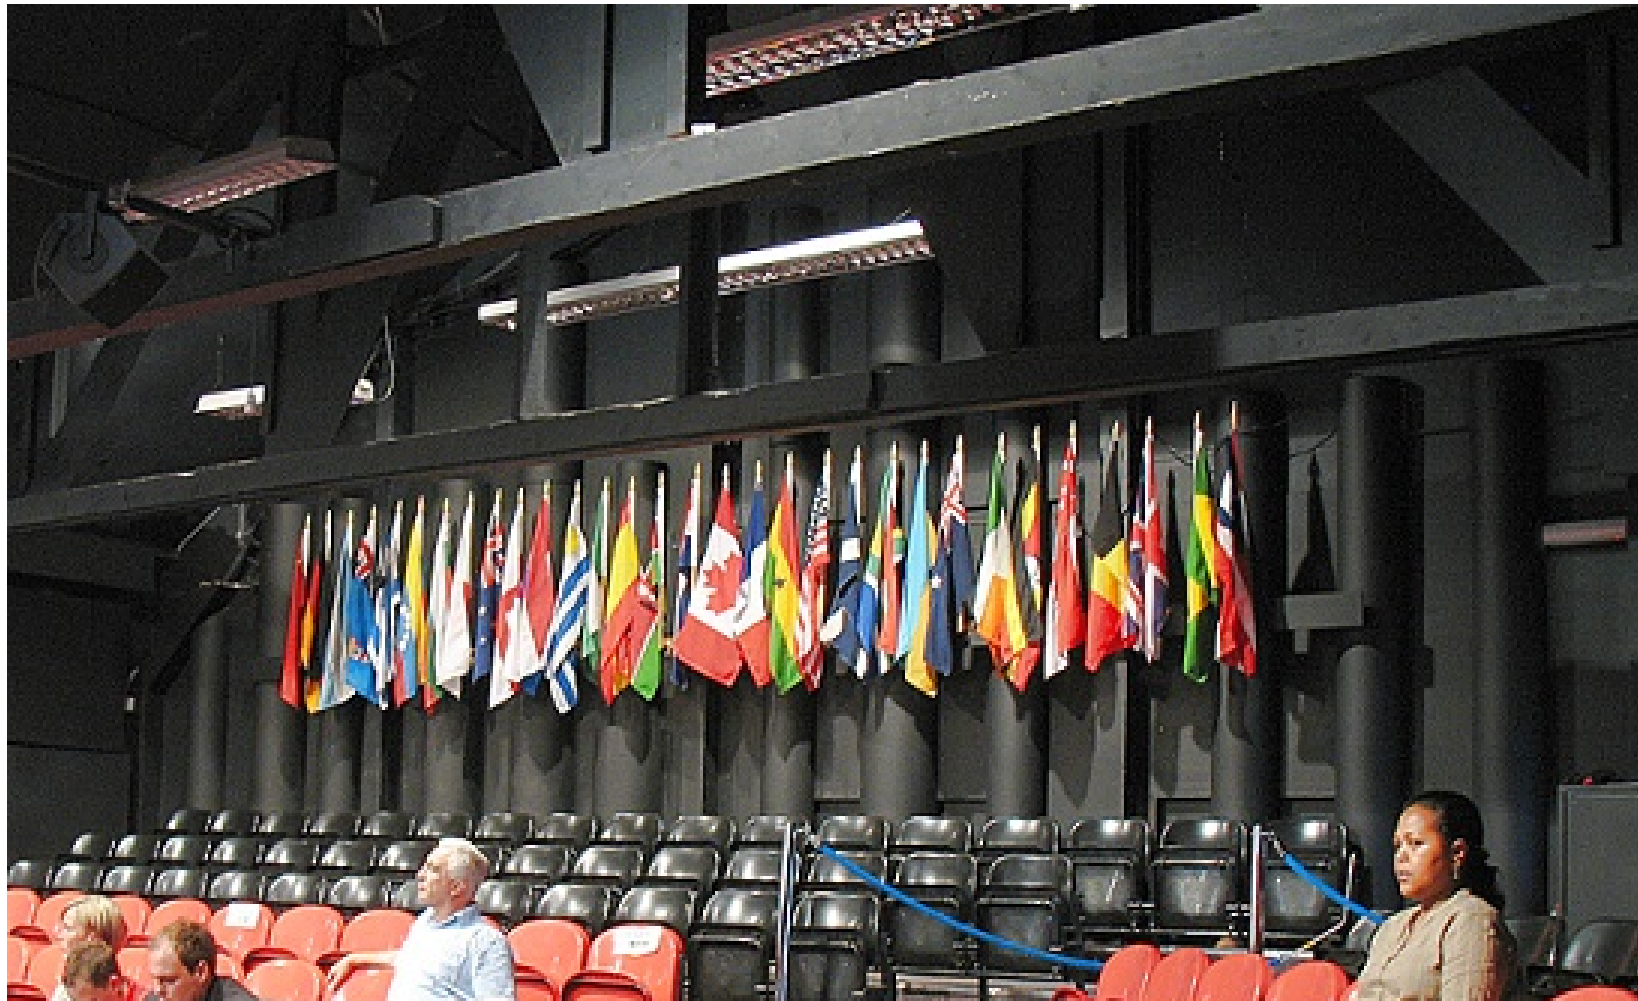
Day 7 Part 3

- ◆ With just minutes before the first worship service, details like the flags and tube up in the trusses were already completed – a big Thank you to all of the terrific church member that helped out.

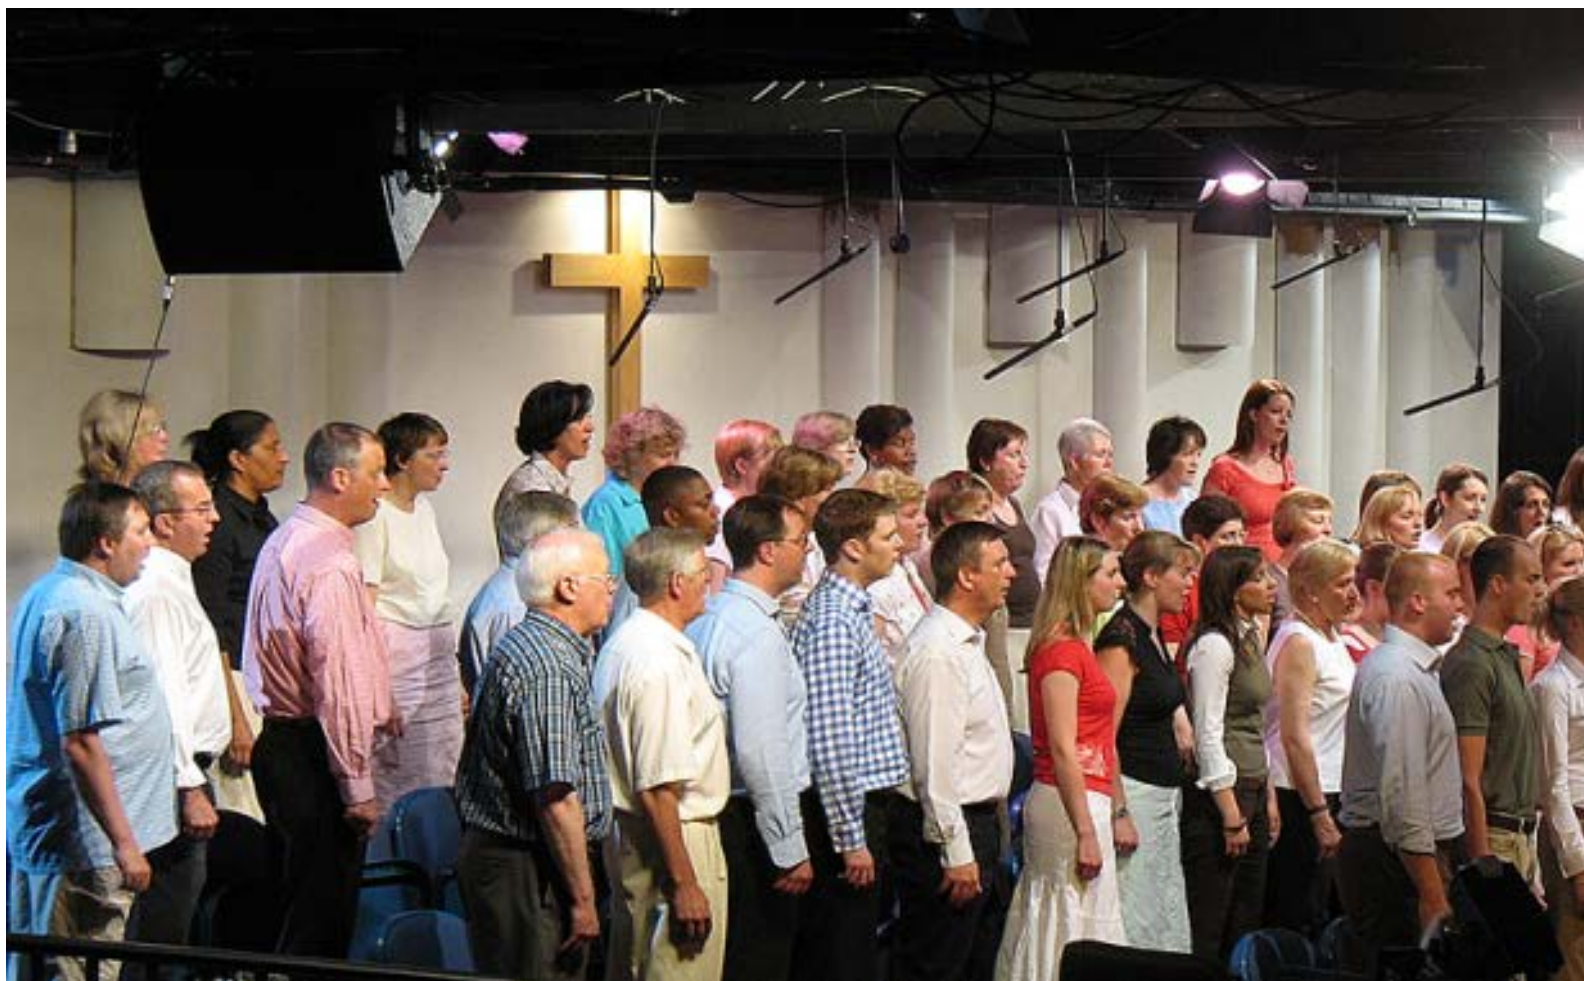
Day 7 Part 4

- ◆ First Service.
- ◆ The choir was too loud – un-amplified – never a problem before. Only a few overhead mics were used for recording purposes. Most of those mics will soon leave.

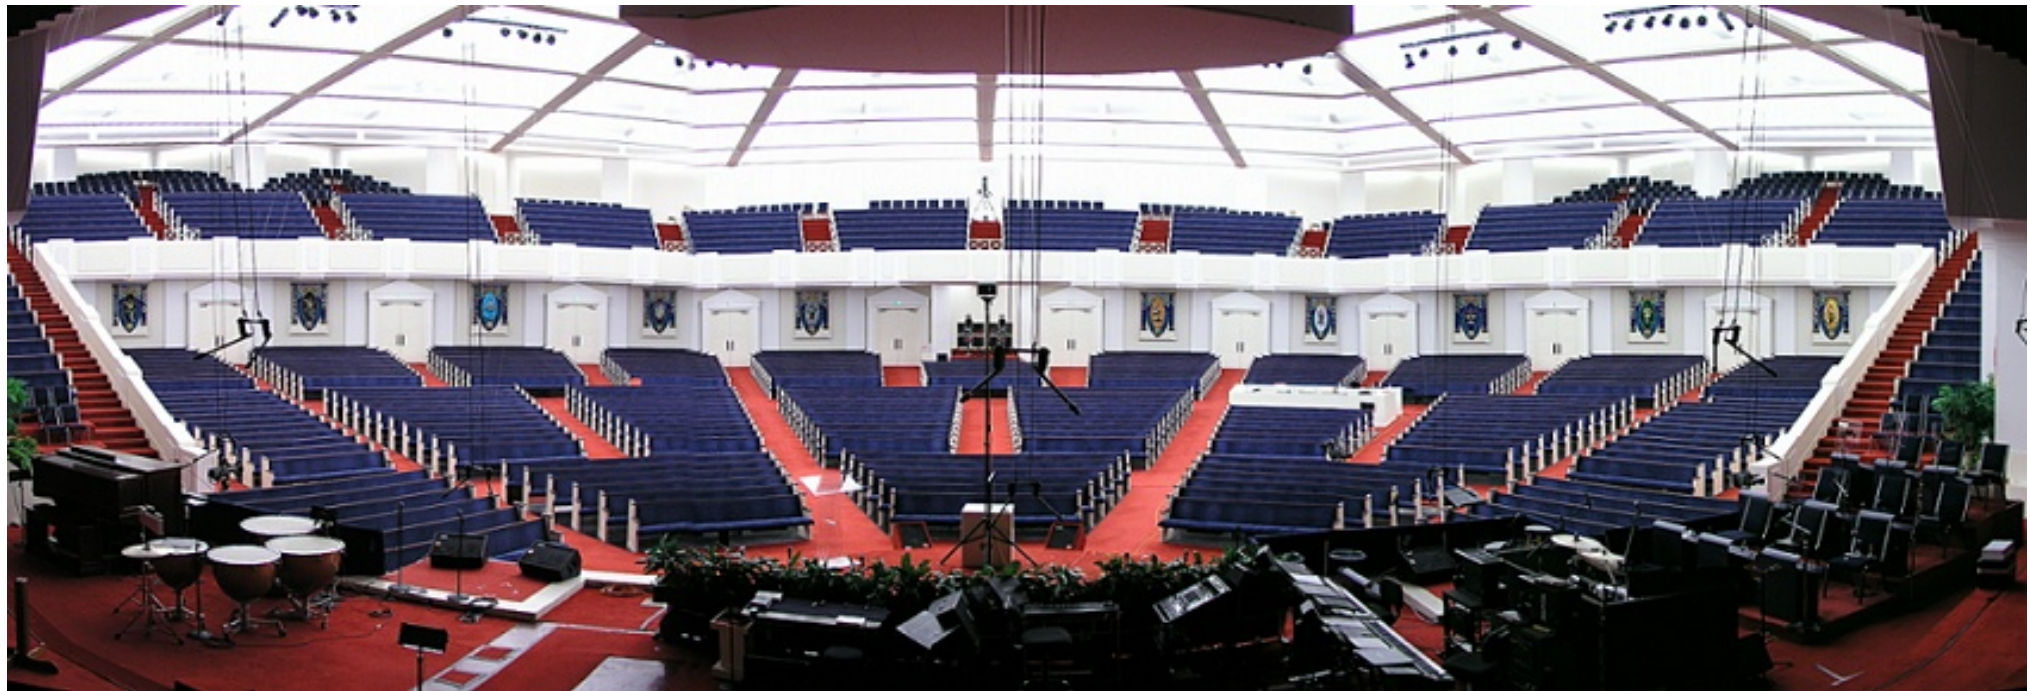
Other Projects

- ◆ For those of you who would like to see my work, your out of luck.
- ◆ Many churches are able to hide my work.
- ◆ You can hear the result, but you often can't see it.
- ◆ This is John Hagee Ministries (Cornerstone Church Texas) Seating over 3,000 and you can not see any of the hundreds of cardboard tubes.

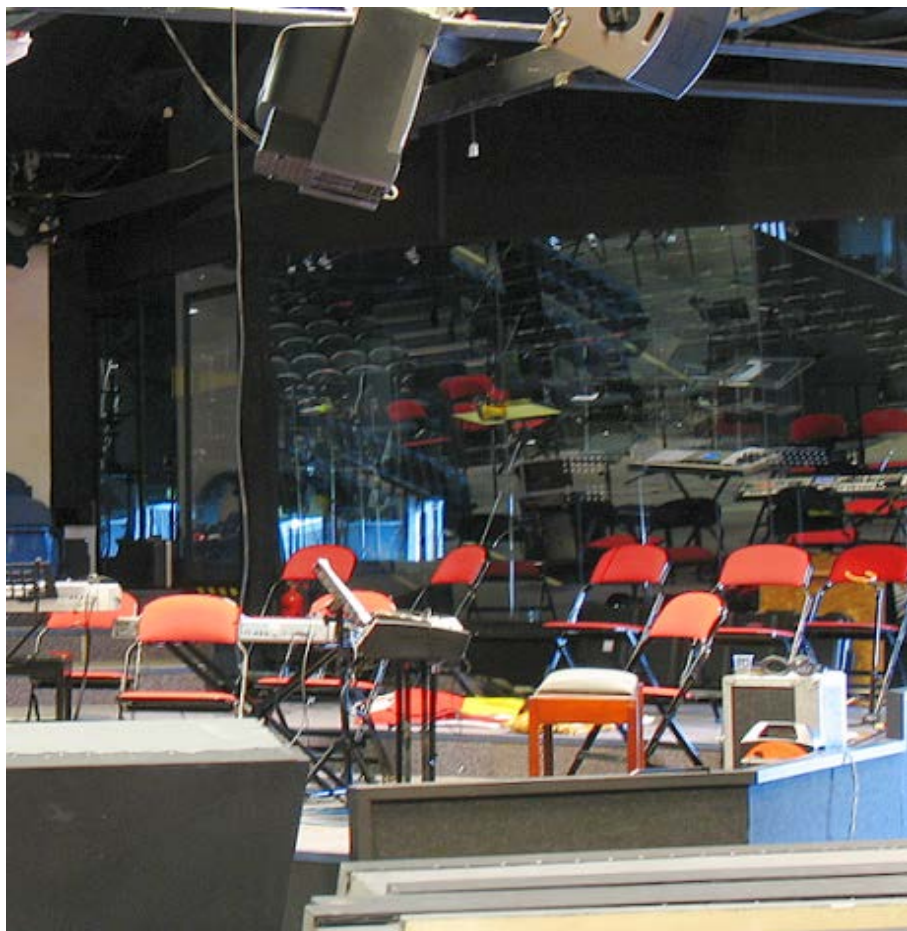
The Music Booth

◆ Now you see a glass booth

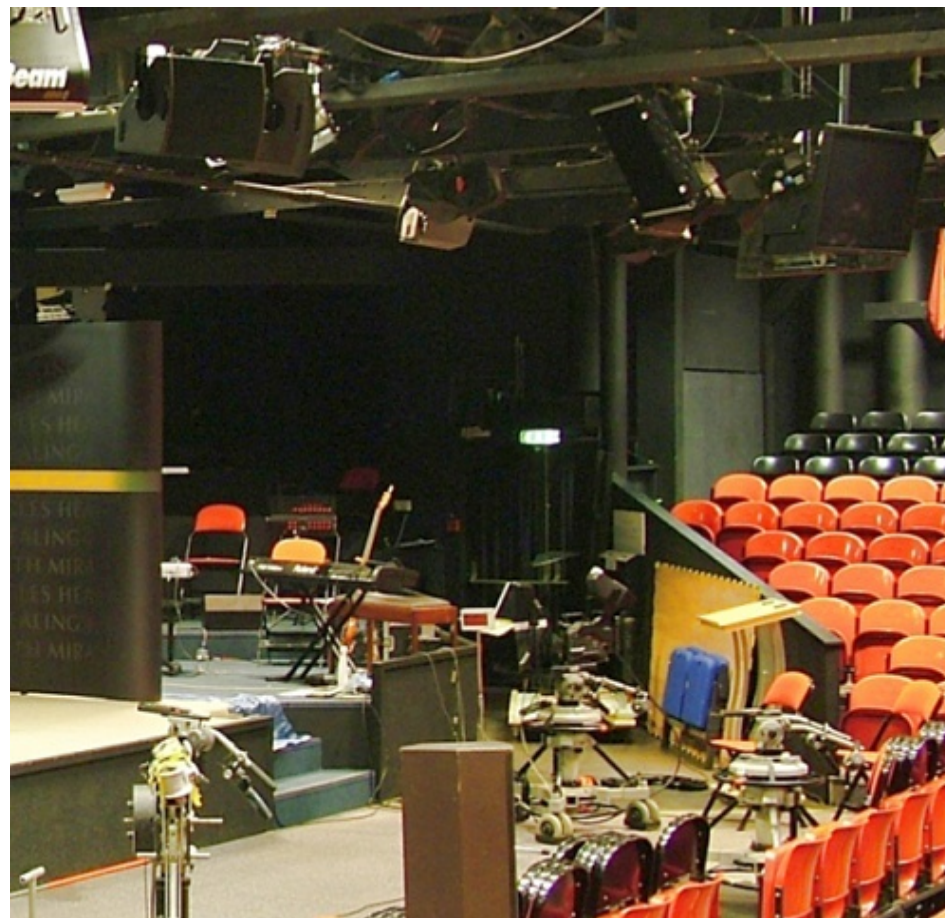
- ◆ Now you Don't
- ◆ When you fix a church to worship quality, drum booths are usually not needed any more

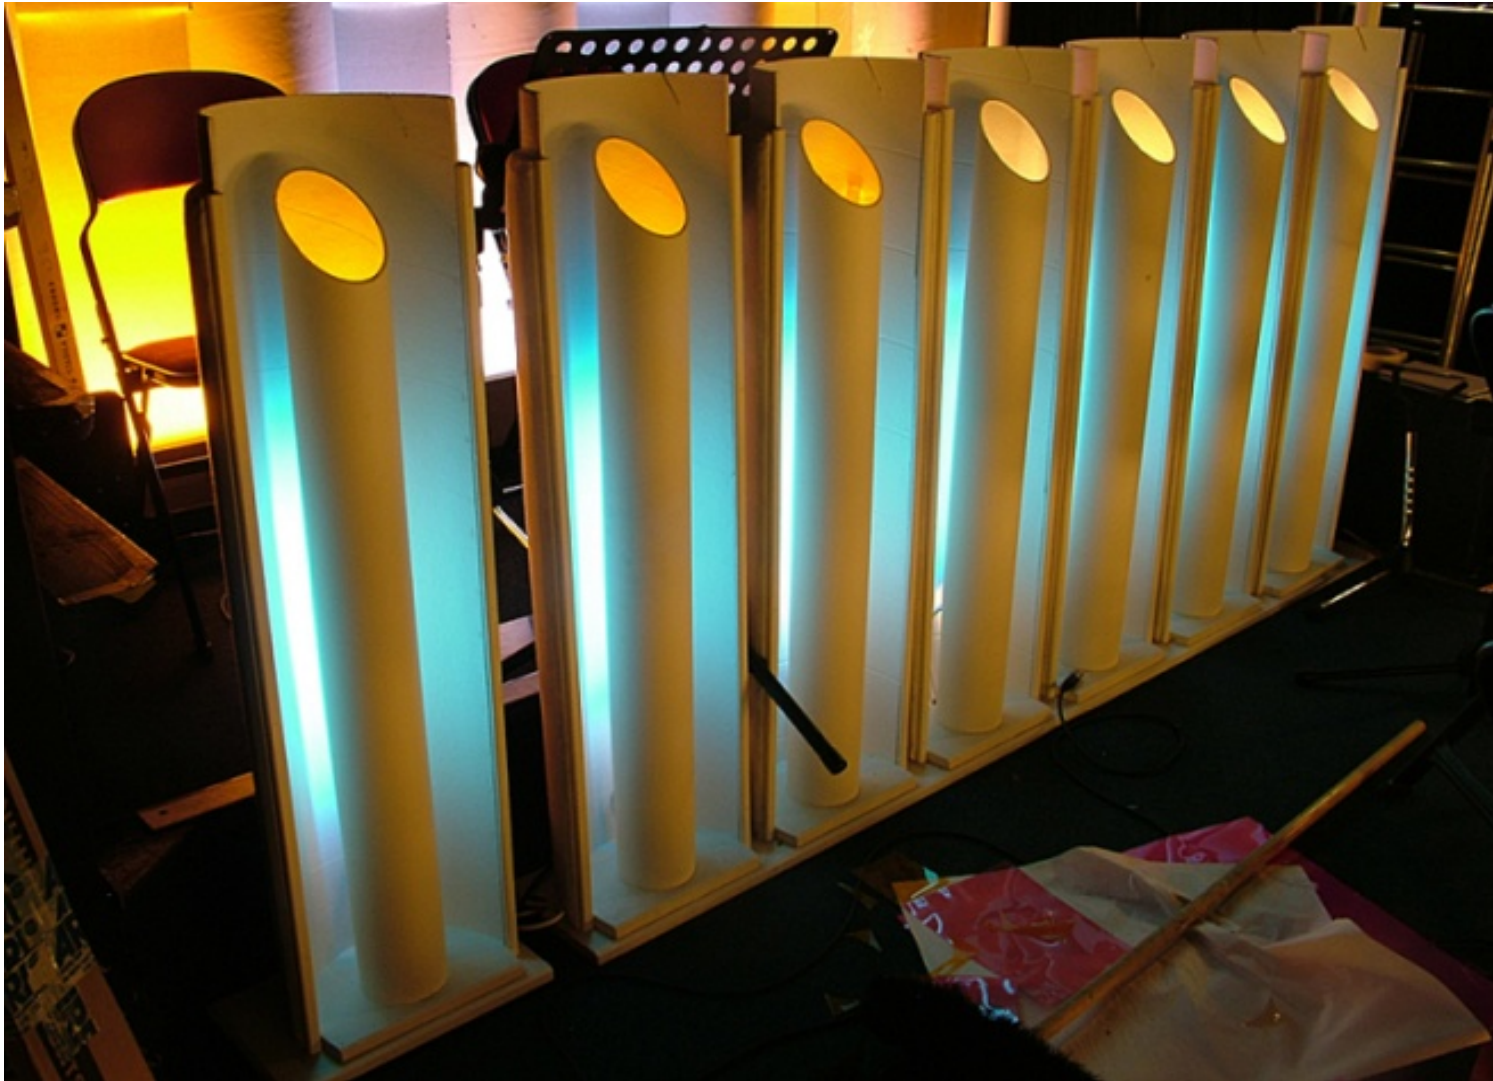
- ◆ After I left England, there were some loose ends that needed to be done. One of them was some extra control of the brass instrument. This is a low profile musicians diffuser trap on one side.

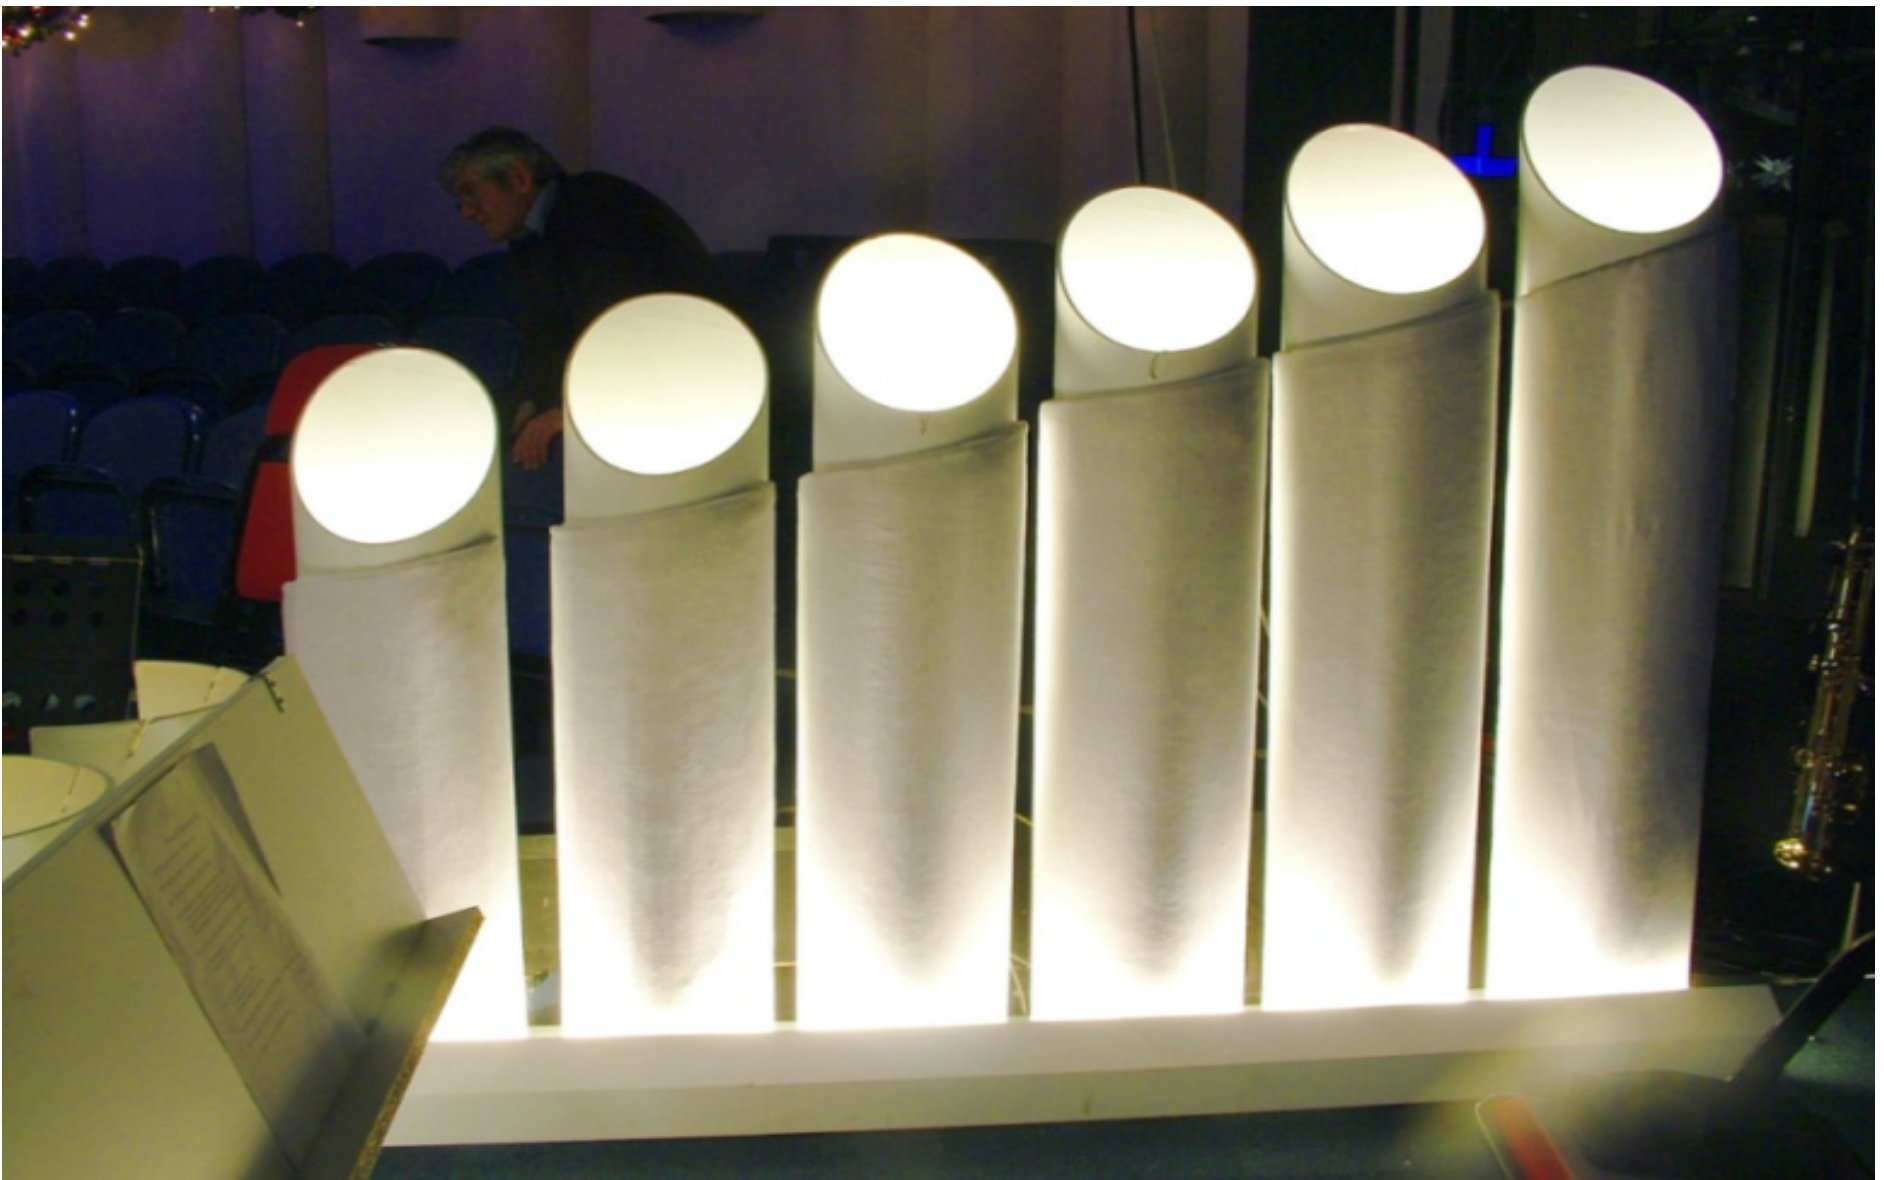
- ◆ This is a divider between the choir and brass. It is an interested way to dress up the tubes. All of the lighting is low voltage.

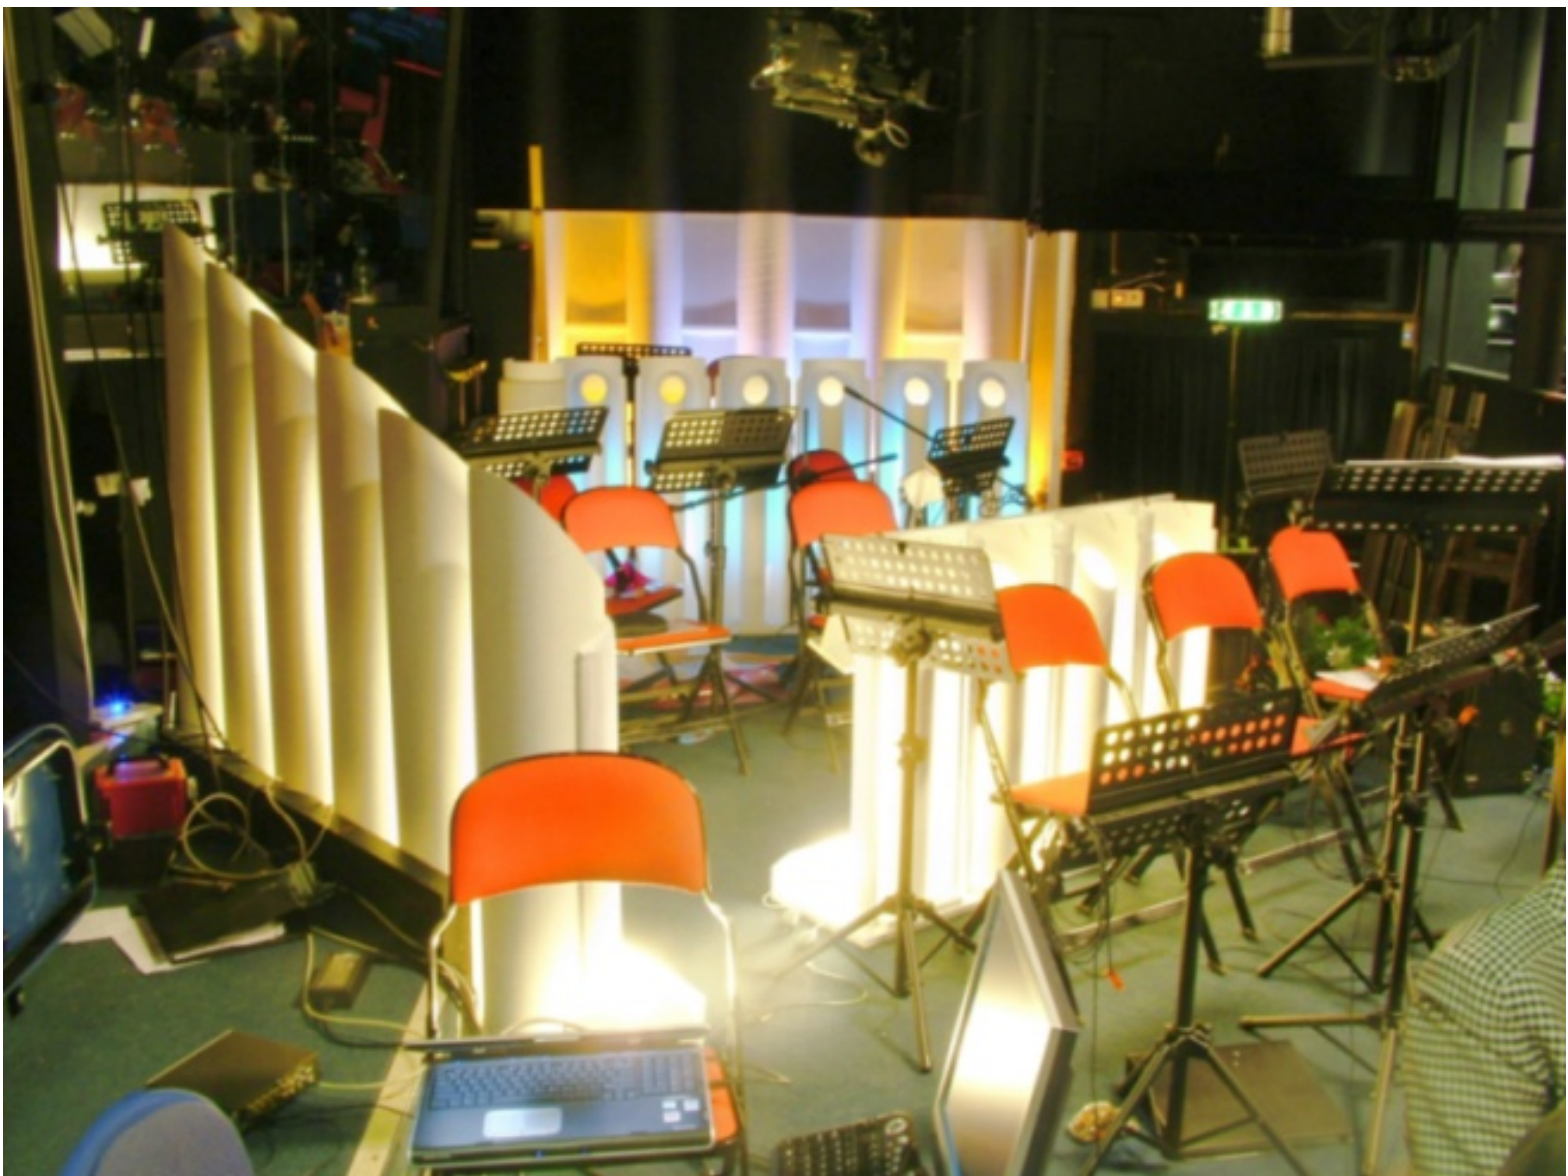
- ◆ This is a view of the orchestra area. Now it is more organized and spill of their sound to the choir has a better balanced for the live sound and the TV broadcast.
